## Inspection Report

Best Choice  
Inspections

Inspector: Jon Walz TN - 1126  
P.O. Box 14205  
Knoxville, TN 37914  
Tel: 865-804-2422  
2/27/2019

Report ID: 022719JW624

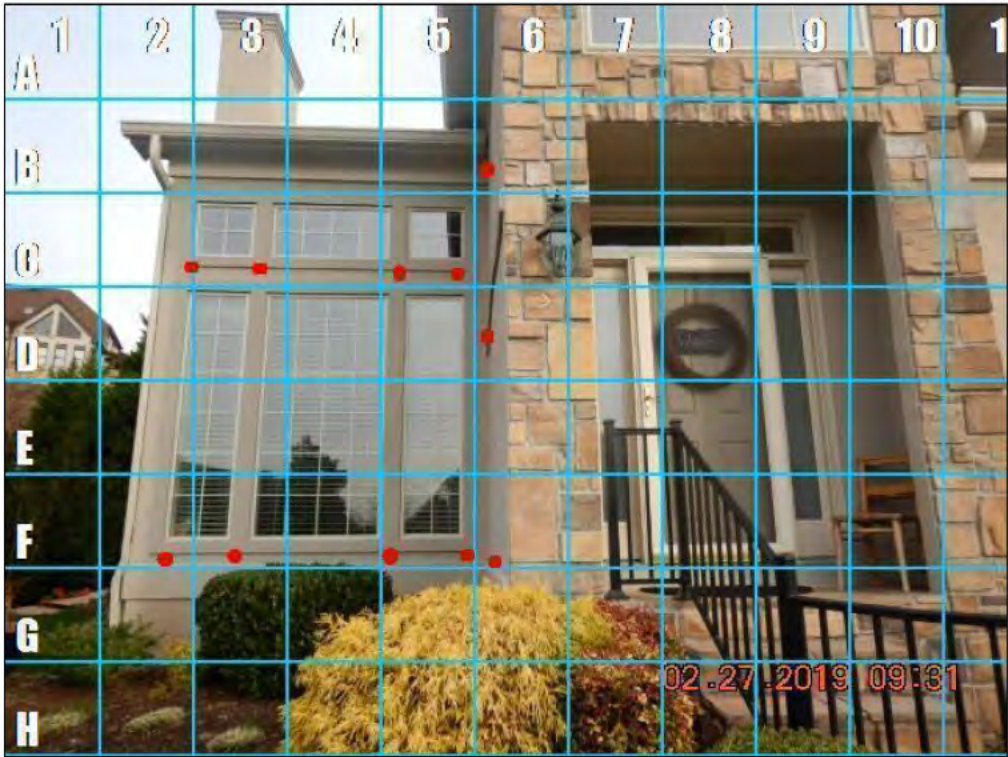
3.0.A Grid View

Grid Location	Item Description	Moisture Readings	Substrate Condition	Observations
C2	Window	11	Firm	Area where moisture reading was obtained.
C3	Window	9	Firm	Area where moisture reading was obtained.
C5	Window	11.2	Firm	Area where moisture reading was obtained.
B6	Window	6.2	Firm	Area where moisture reading was obtained.
D6	Kickout	11.7	Firm	Area where moisture reading was obtained.
F6	Kickout	9.1	Firm	Area where moisture reading was obtained.
F2	Kickout	7.2	Firm	Area where moisture reading was obtained.
F3	Window	0, 11.1	Firm	Area where moisture reading was obtained.
F5	Window	6.7	Firm	Area where moisture reading was obtained.

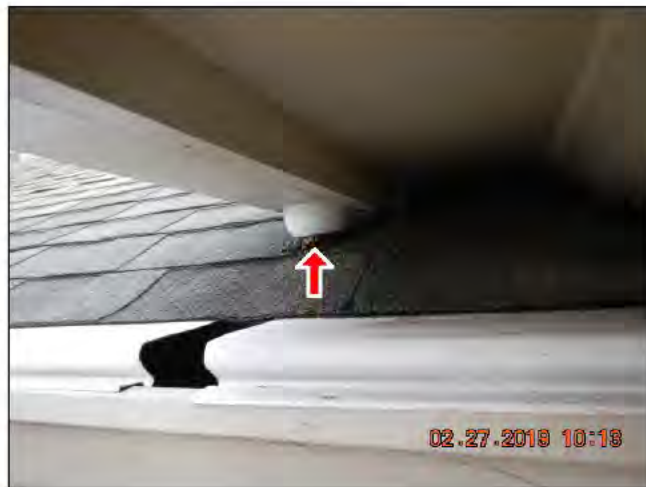
**3.1.A B5**

Gutter outlet above kickout which empties onto roof appears clogged. Clean all debris from gutters to allow water to drain properly.

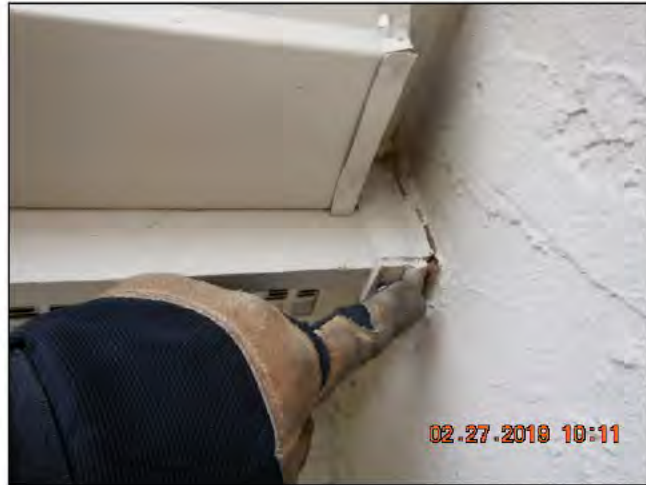
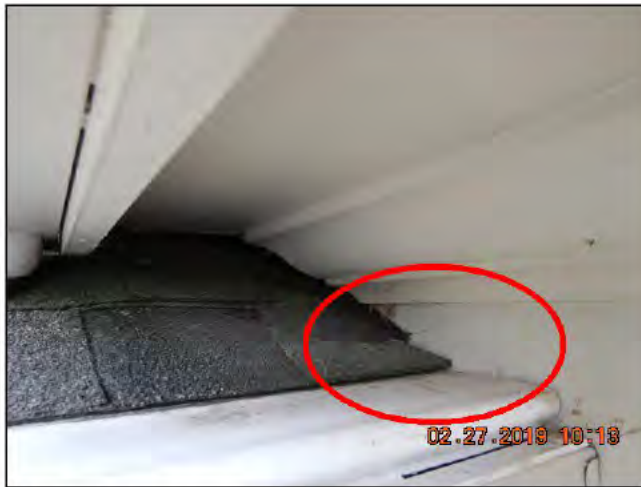
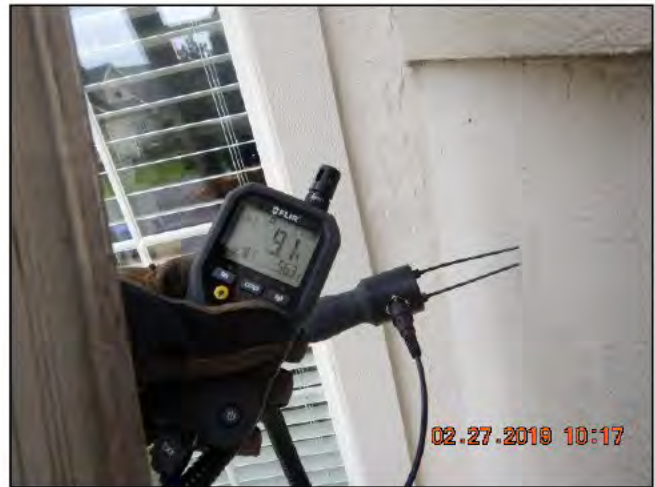
**3.2.A B6**

(1) Wood rot under kickout at left side of front entry. Repair / replace all damaged wood.

(2) No kickout installed at this location. This area is sheltered, however, poor drainage and / or blown rain may still need to be directed away from sidewall. Recommend repair.

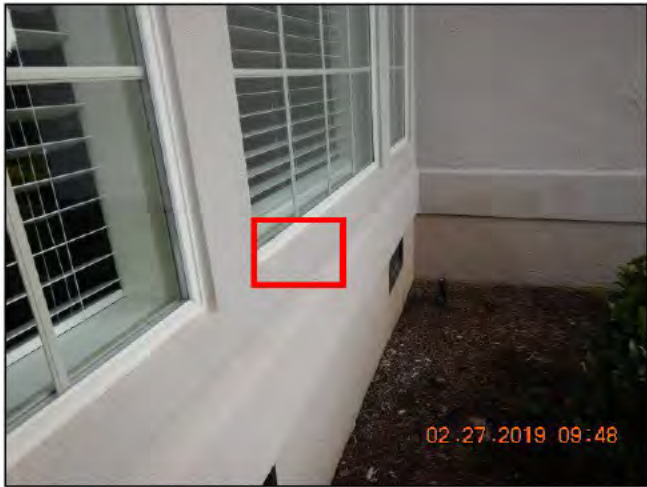
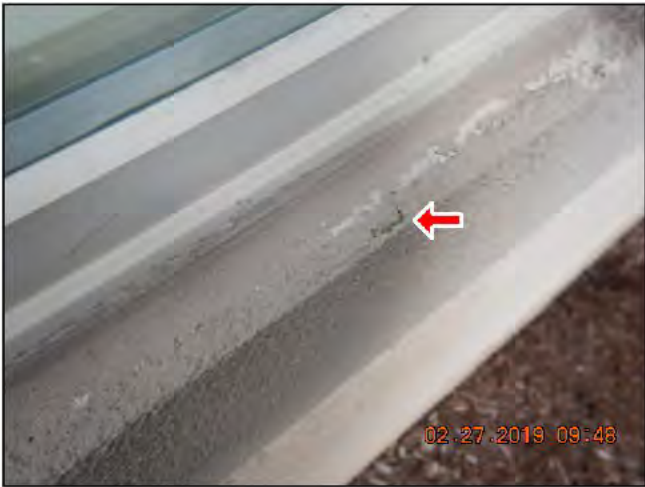
### 3.3.A F3

Damage / visible mesh at EIFS window trim detail. Repair all damage.

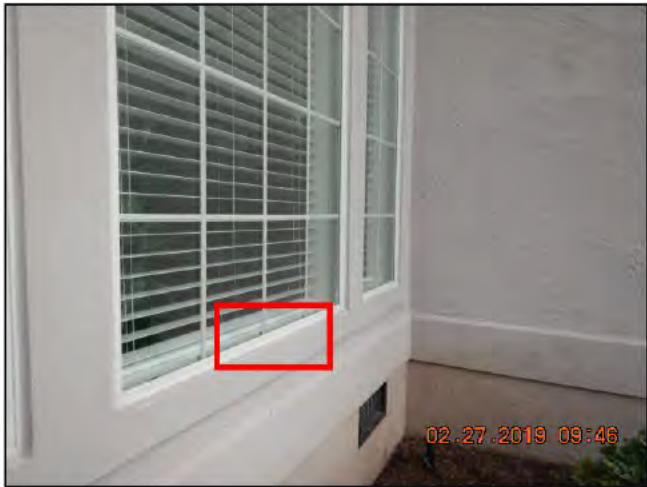
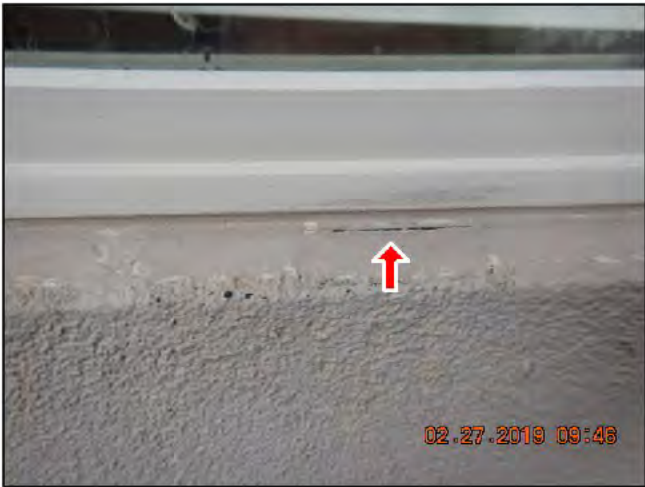
3.4.A F4

Caulking failing at window. Typical at most window. Recommend repair / caulk as needed.

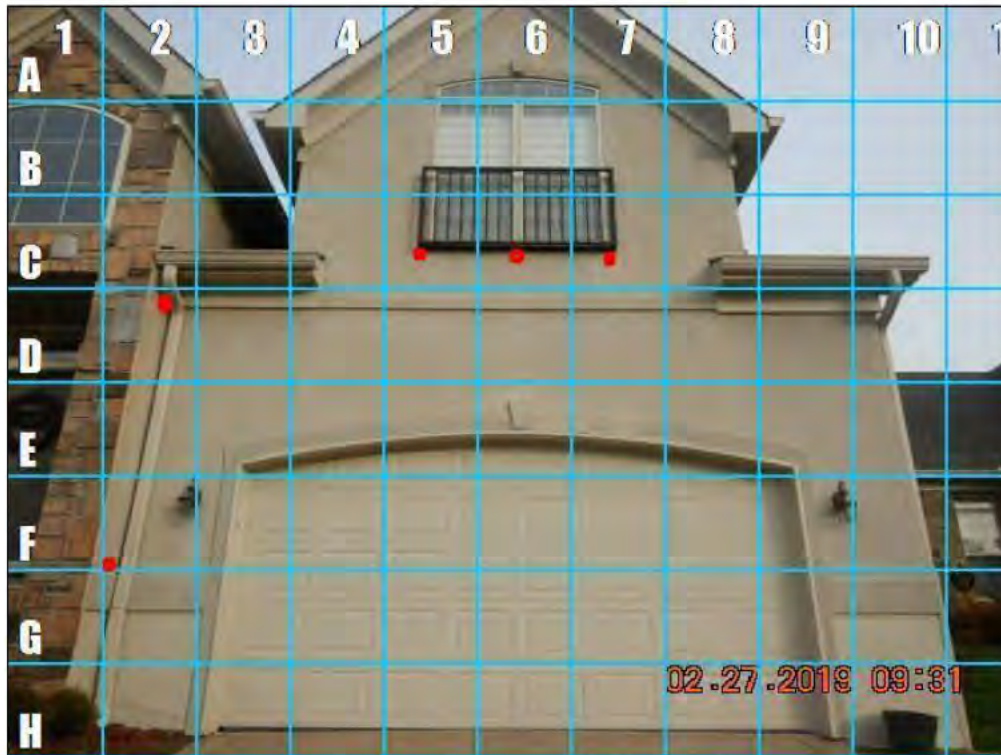
3.0.B Grid View

Grid Location	Item Description	Moisture Readings	Substrate Condition	Observations
D2	Kickout	10.7	Firm	Area where moisture reading was obtained.
F2	Kickout	9.4	Firm	Area where moisture reading was obtained.
C5	Window	30.9	Firm	Elevated moisture below window.
C6	Window	32.2	Soft	Elevated moisture below window.
C7	Window	41.2	Soft	Elevated moisture below window.

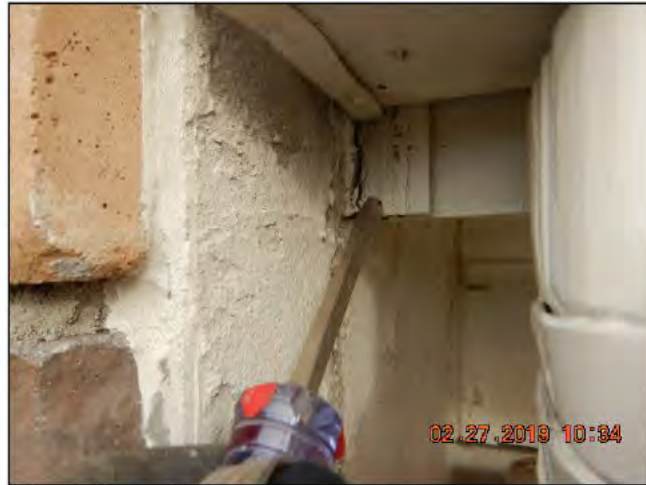
**3.1.B C2**

Wood rot under kickout at left side of front entry. Repair / replace all damaged wood.

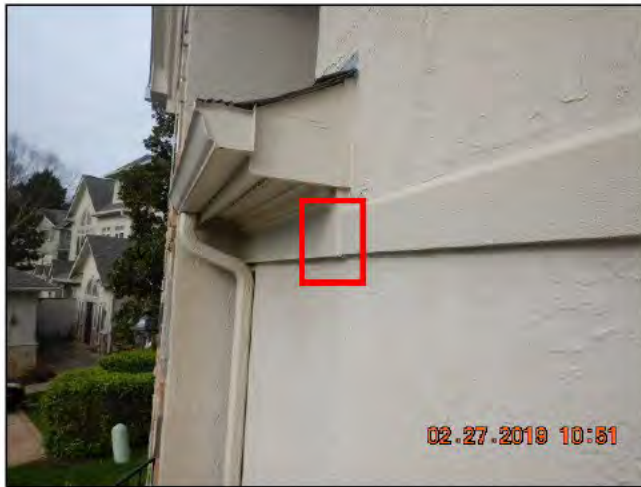
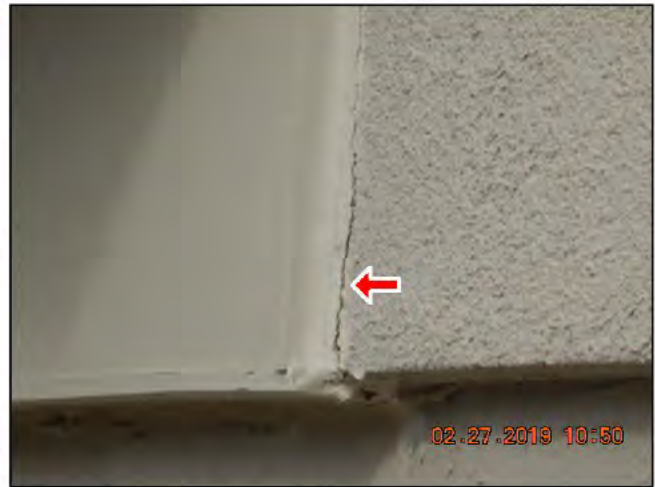
### 3.2.B C4

Caulk failing at frieze board. Typical at most areas. Recommend repair / caulk as needed.

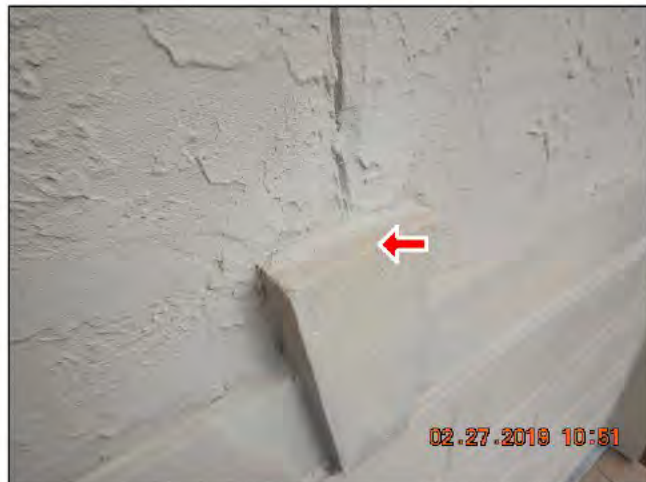
### 3.3.B E6

Flat accent above garage door. Slope recommended to properly drain water on all accents that extend more than 1 and 1/2 inch from wall. Recommend repair.

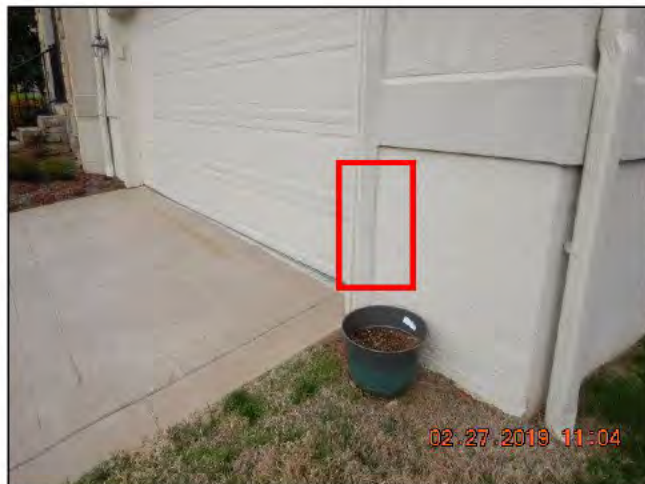
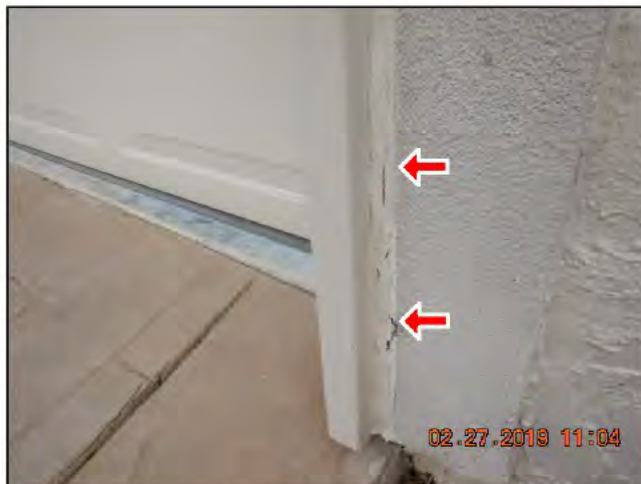
3.4.B G9

Caulk failing at door. Recommend repair / caulk as needed.

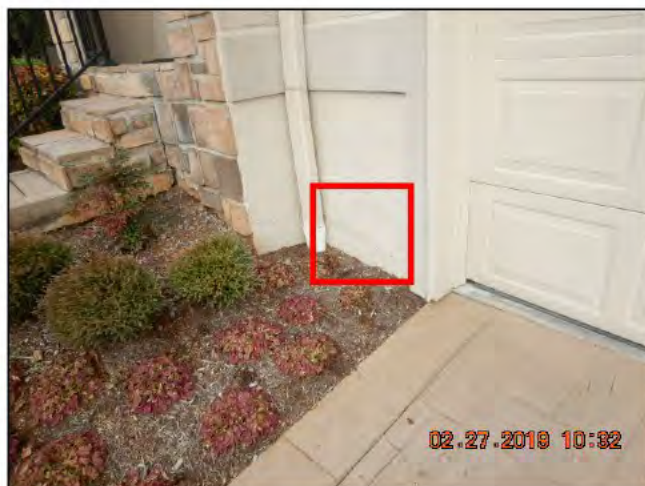
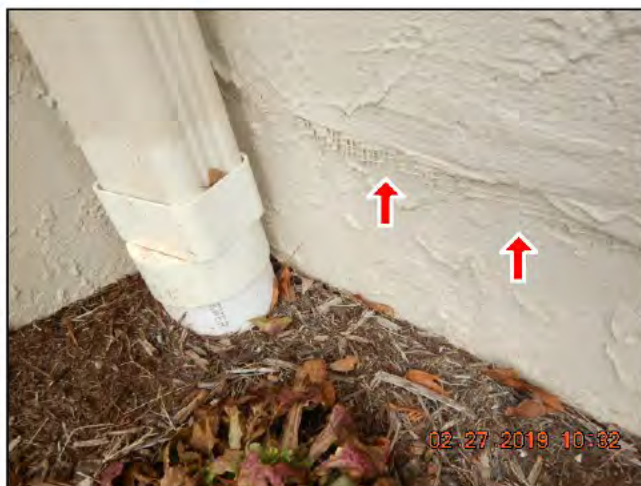
3.5.B H2

Mesh visible. No foam in this area. Mesh and finish coat over block. Repair.

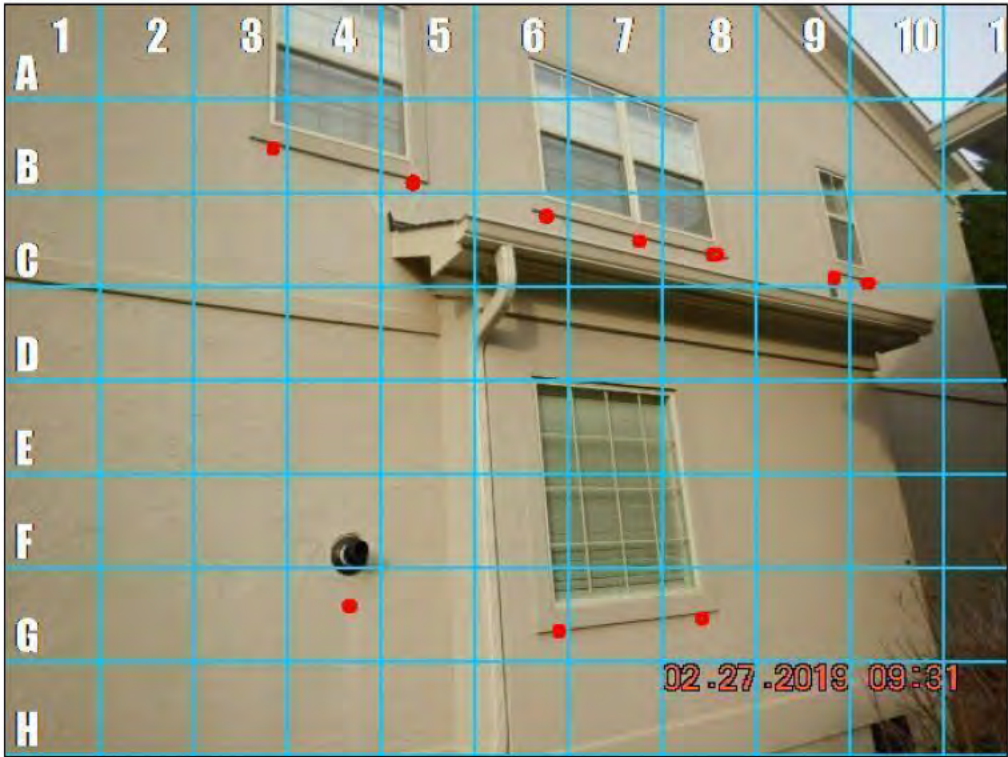
4.0 GRID VIEW

Grid Location	Item Description	Moisture Readings	Substrate Condition	Observations
G4	Vent Duct	7.8	Firm	Area where moisture reading was obtained.
B3	Window	7.9	Firm	Area where moisture reading was obtained.
B5	Window	40.6	Firm	Elevated moisture below window.
C6	Window	33.7	Firm	Elevated moisture below window.
C7	Window	13.9	Firm	Area where moisture reading was obtained.
C8	Window	11.6	Firm	Area where moisture reading was obtained.
C9	Window	19.1	Firm	Elevated moisture below window.
C10	Window	21.7	Firm	Elevated moisture below window.
G6	Window	10.1	Firm	Area where moisture reading was obtained.
G8	Window	13.2	Firm	Area where moisture reading was obtained.

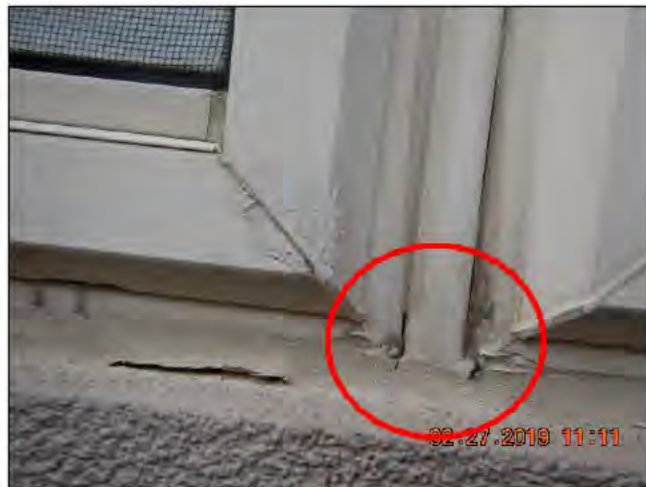
**4.1 C7**

Caulk failing at millions at joined windows. Typical at all joined windows. Recommend repair / caulk as needed.

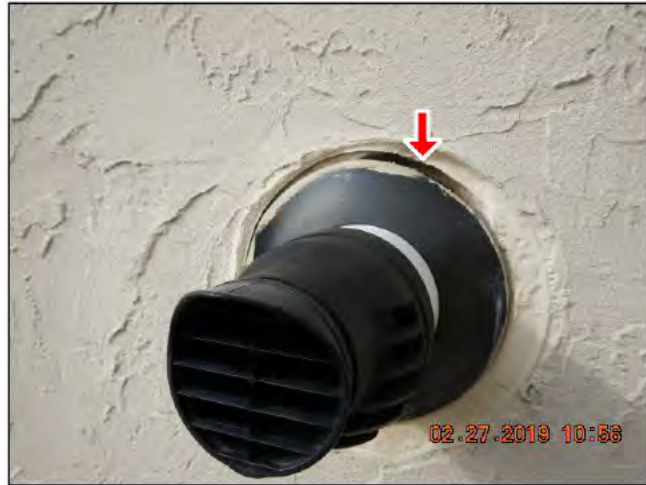
**4.2 F4**

Large gap above exhaust / intake pipe. Repair / caulk as needed.

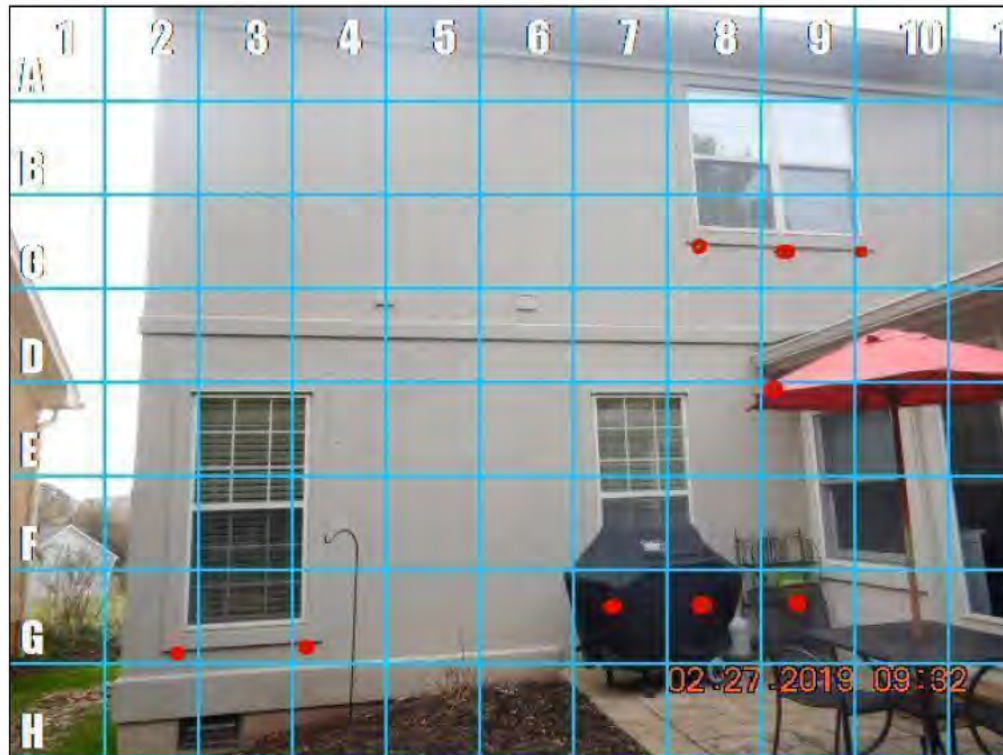
### 5.0.A GRID VIEW

Grid Location	Item Description	Moisture Readings	Substrate Condition	Observations
G2	Window	9.2	Firm	Area where moisture reading was obtained.
G4	Window	8.2	Firm	Area where moisture reading was obtained.
G7	Window	7.4	Firm	Area where moisture reading was obtained.
G8	Window	24.5	Firm	Elevated moisture below window.
C8	Window	12	Firm	Area where moisture reading was obtained.
C9	Window	14.8	Firm	Area where moisture reading was obtained.
C10	Window	10.2	Firm	Area where moisture reading was obtained.
E9	Kickout	8.4	Firm	Area where moisture reading was obtained.
G9	Kickout	12.4	Firm	Area where moisture reading was obtained.

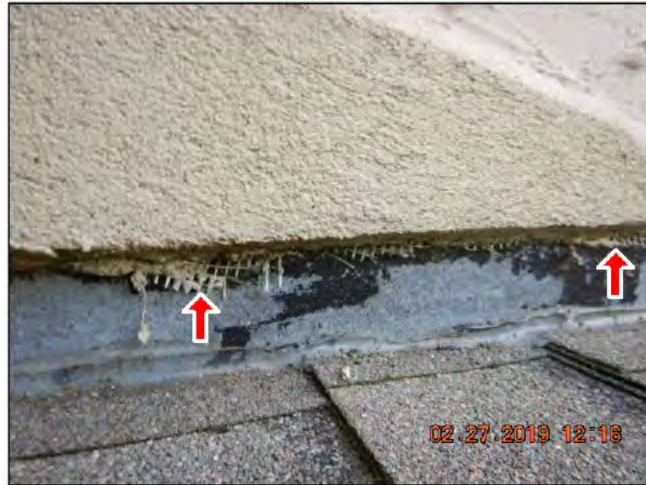
## 5.1.A D9

Mesh visible at bottom of EIFS.

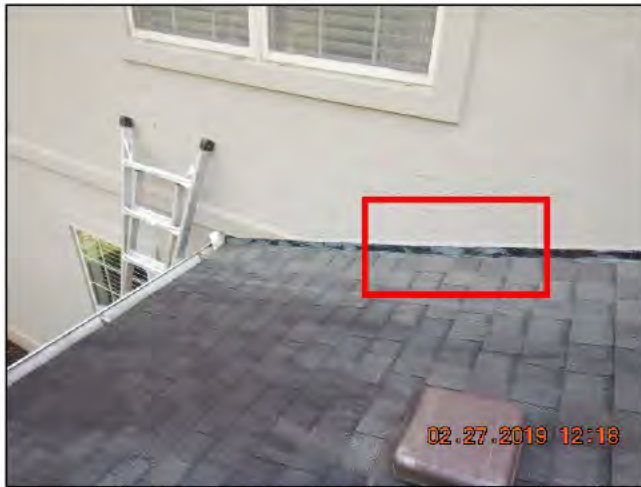
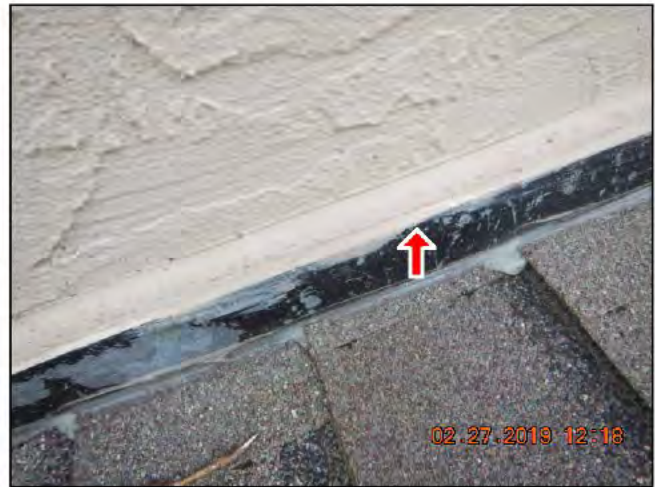
### 5.2.A D10

Drainage outlet should remain unobstructed to allow proper drainage of system. No visible J-channel or drip screed at bottom edge, typical at all wall to roof locations.

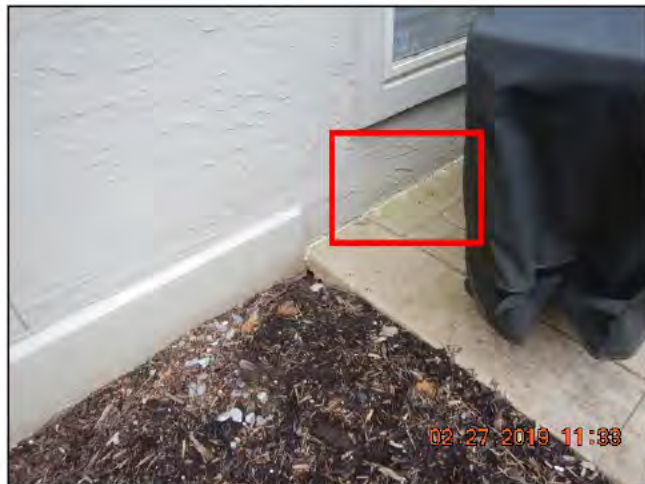
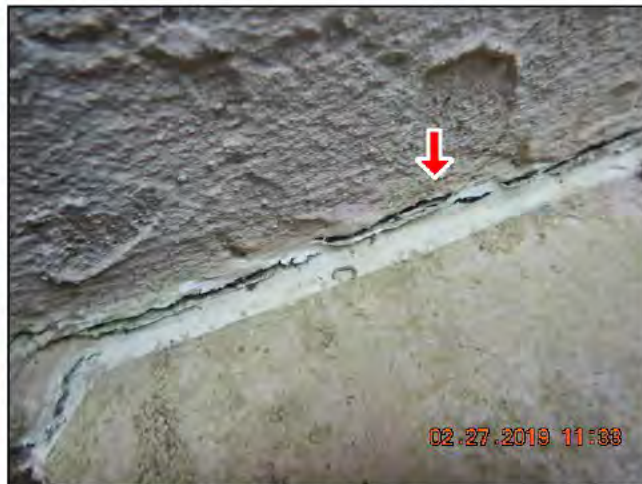
### 5.3.A G7

Caulk installed at stucco to concrete joint. No visible J-Channel or drip screed. Caulk failing.

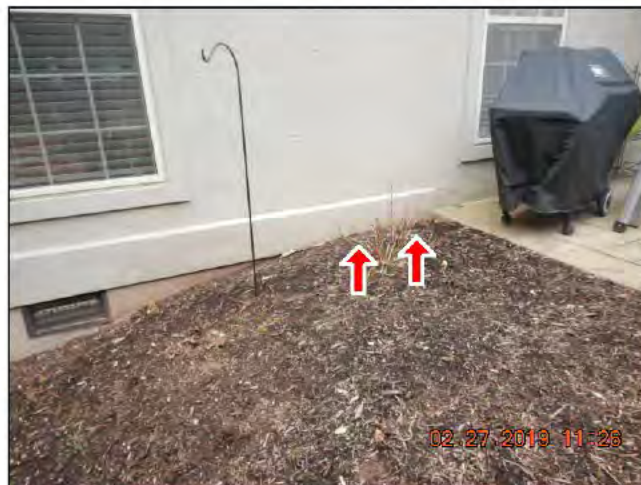
#### 5.4.A H6

EIFS is installed below grade at this area. Manufacturers recommend that stucco is terminated above grade to prevent moisture and pest intrusion. Pull mulch back and ensure positive slope away from home. Recommend repair.

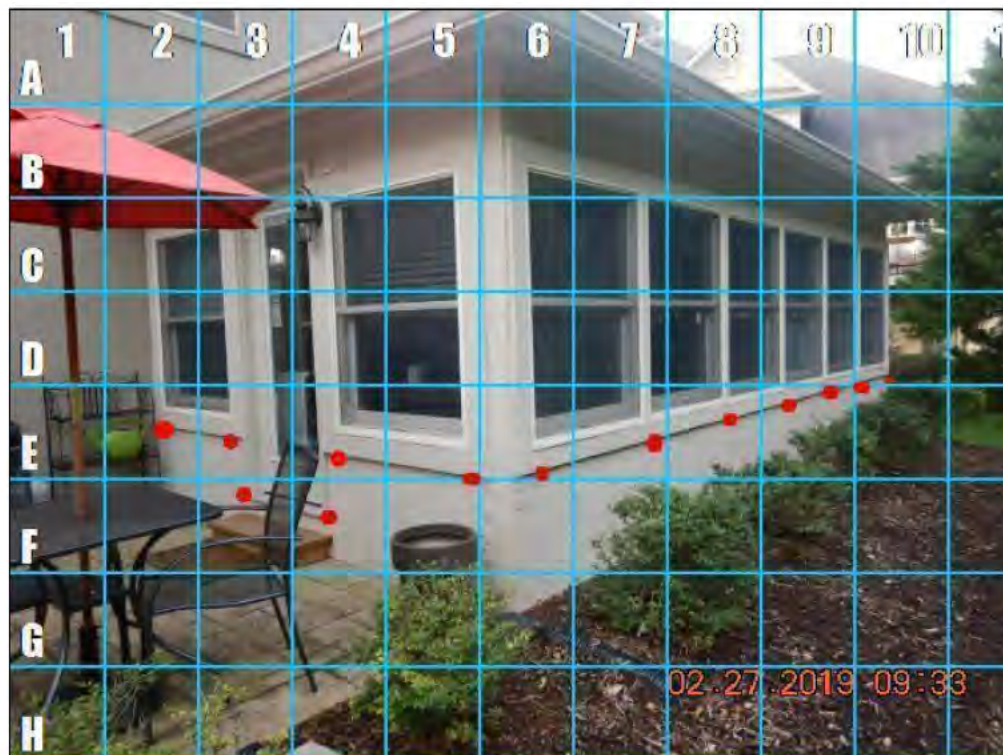
#### 5.0.B GRID VIEW

Grid Location	Item Description	Moisture Readings	Substrate Condition	Observations
E2	Window	10.9	Firm	Area where moisture reading was obtained.
E3	Window	8.7	Firm	Area where moisture reading was obtained.
E4	Window	8.5	Firm	Area where moisture reading was obtained.
E5	Window	9.4	Firm	Area where moisture reading was obtained.
E6	Window	7.3	Firm	Area where moisture reading was obtained.
E7	Window	7.5	Firm	Area where moisture reading was obtained.
E8	Window	7.6	Firm	Area where moisture reading was obtained.
E9	Window	10.4, 8.6	Firm	Area where moisture reading was obtained.
E10	Window	7.4	Firm	Area where moisture reading was obtained.
D10	Window	7.6	Firm	Area where moisture reading was obtained.
F3	Door	12.4	Firm	Area where moisture reading was obtained.
F4	Door	13.8	Firm	Area where moisture reading was obtained.

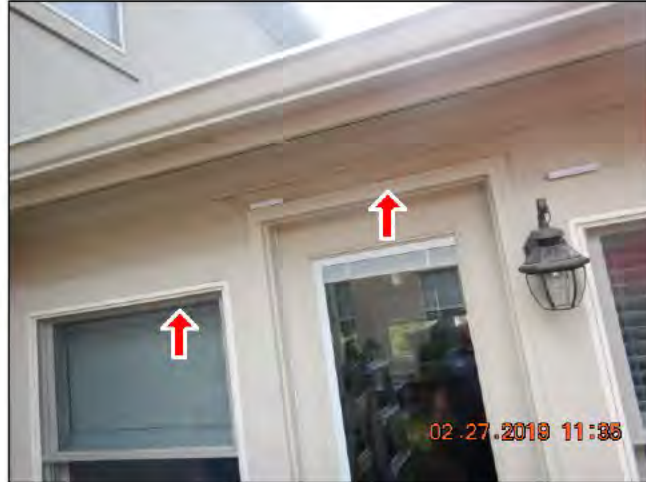
### 5.1.B C3

No head flashing installed at windows and doors at sunroom.

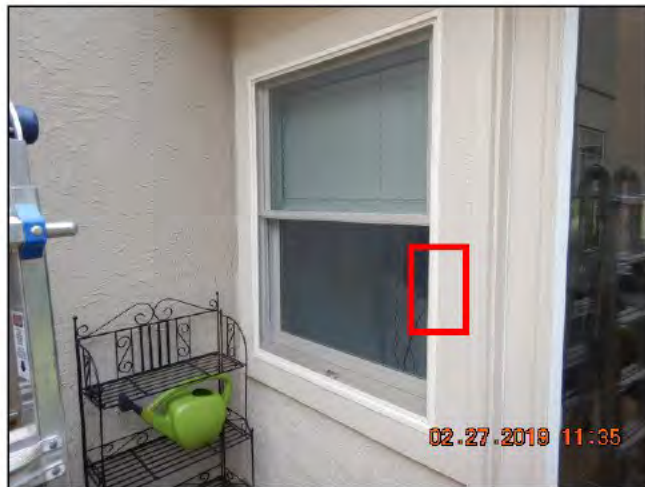
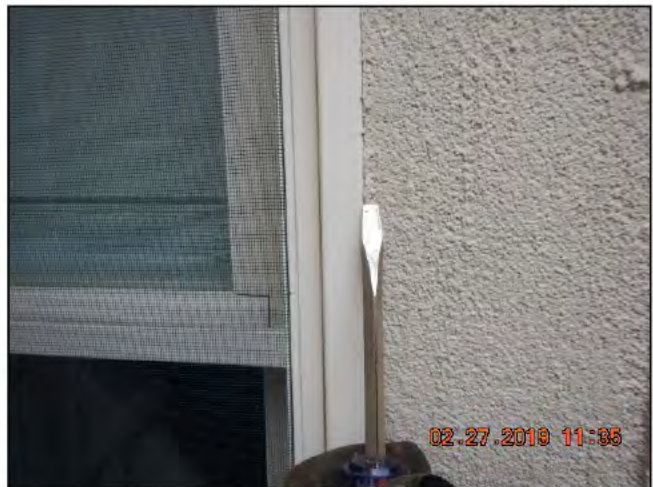
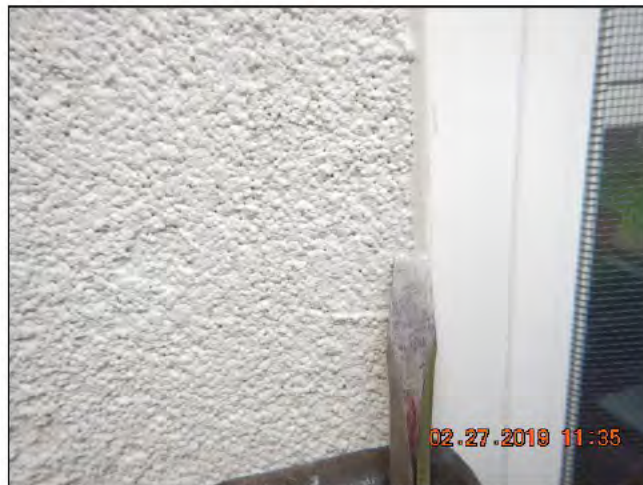
### 5.2.B D3

Caulk missing or thin. Typical at all sunroom windows and doors.

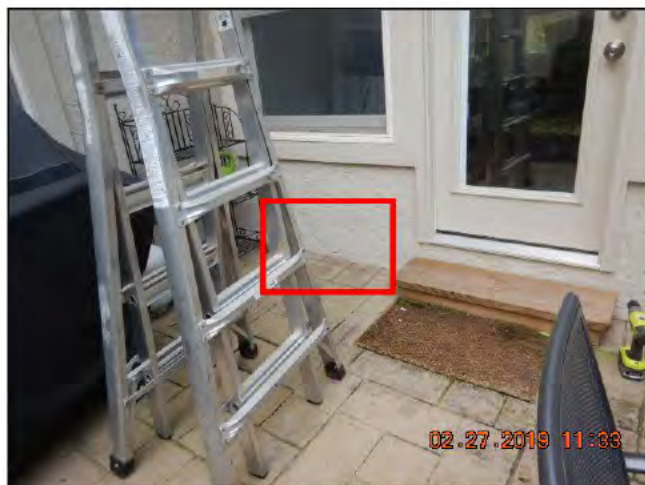
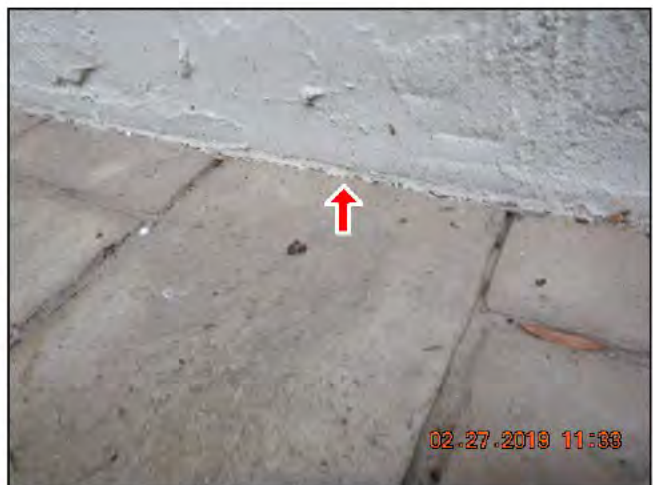
### 5.3.B F2

Stucco in contact with concrete, no visible J- channel or drip screed.

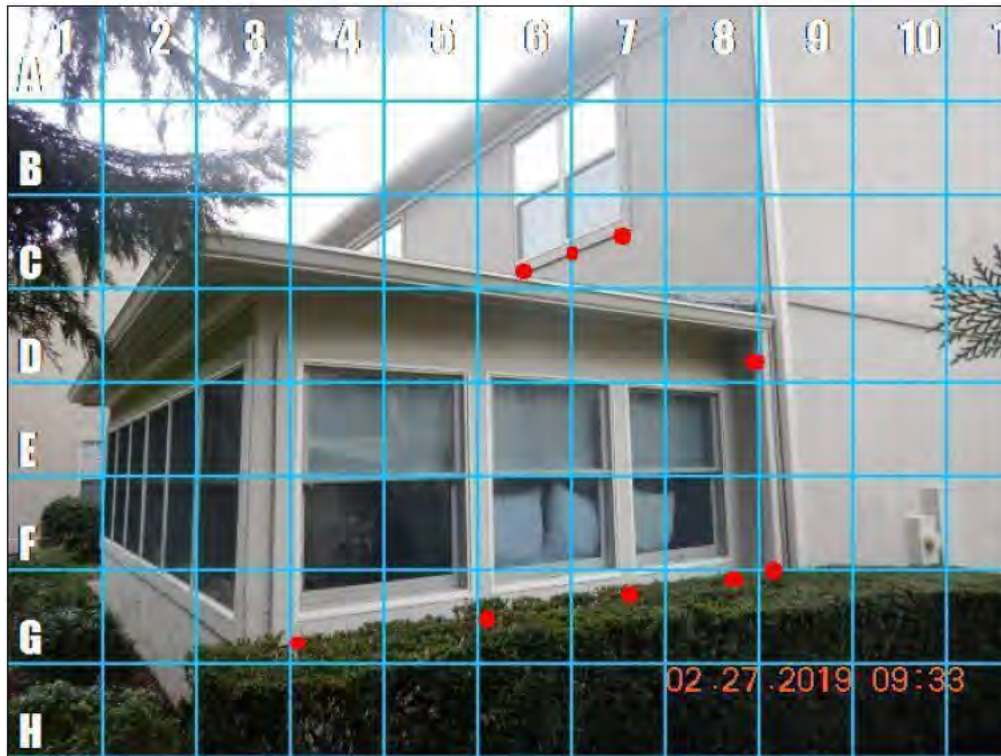
### 5.0.C GRID VIEW

Grid Location	Item Description	Moisture Readings	Substrate Condition	Observations
C6	Window	11.2	Firm	Area where moisture reading was obtained.
C7	Window	14.2, 9.1	Firm	Area where moisture reading was obtained.
G4	Window	8.0	Firm	Area where moisture reading was obtained.
G6	Window	8.3	Firm	Area where moisture reading was obtained.
G7	Window	8.5	Firm	Area where moisture reading was obtained.
G8	Window	9.8	Firm	Area where moisture reading was obtained.
D8	Kickout	9.9	Firm	Area where moisture reading was obtained.
G9	Kickout	9.2	Firm	Area where moisture reading was obtained.

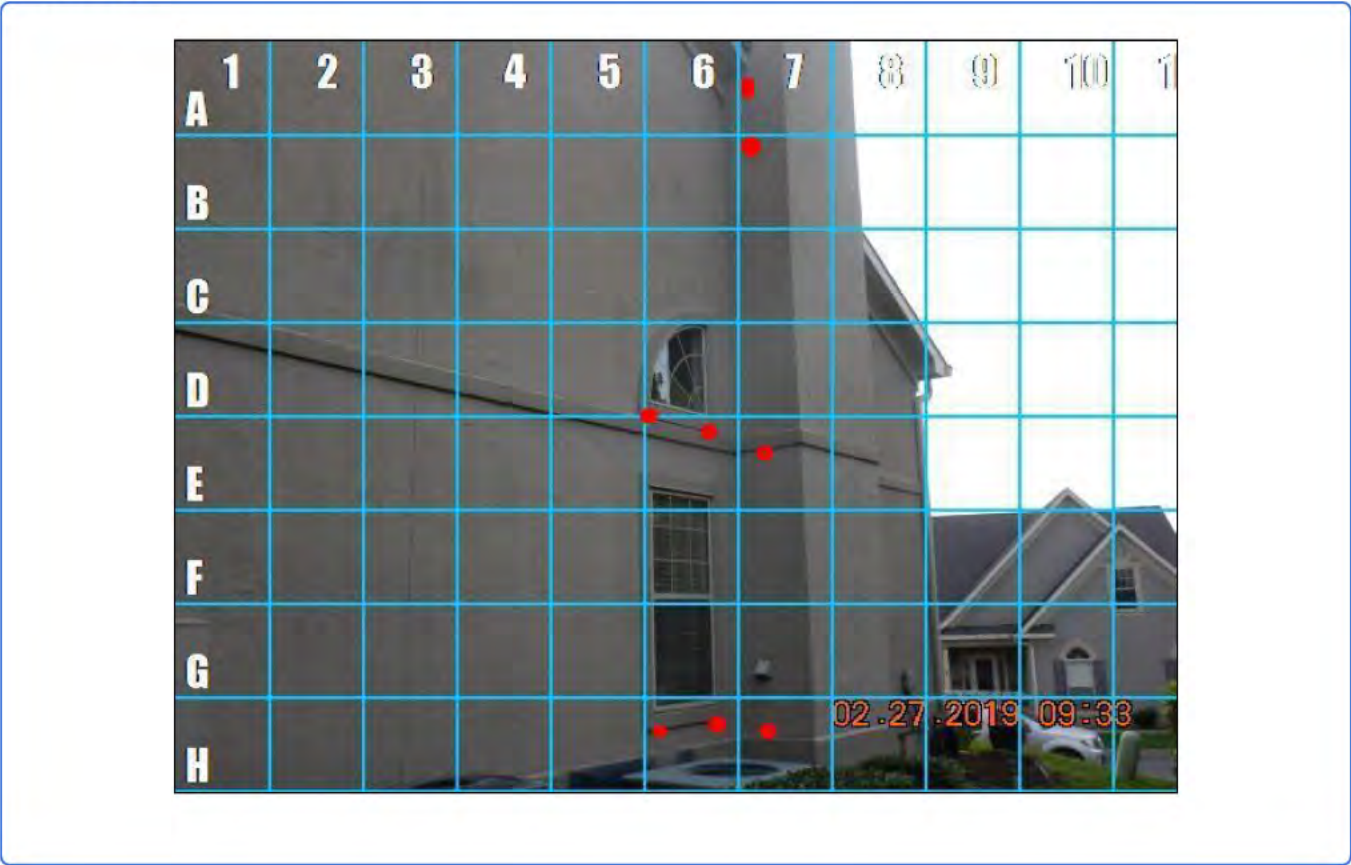
6.0.A GRID VIEW

Grid Location	Item Description	Moisture Readings	Substrate Condition	Observations
A7	Kickout	30.2	Firm	Elevated moisture below kickout.
B7	Kickout	13.6	Firm	Area where moisture reading was obtained.
D7	Kickout	11.5	Firm	Area where moisture reading was obtained.
H7	Kickout	24	Soft	Elevated moisture below kickout.
D6	Window	29.7	Firm	Elevated moisture below window.
E6	Window	8.2	Firm	Area where moisture reading was obtained.
H6	Window	19.2, 14.9	Firm	Elevated moisture below window.

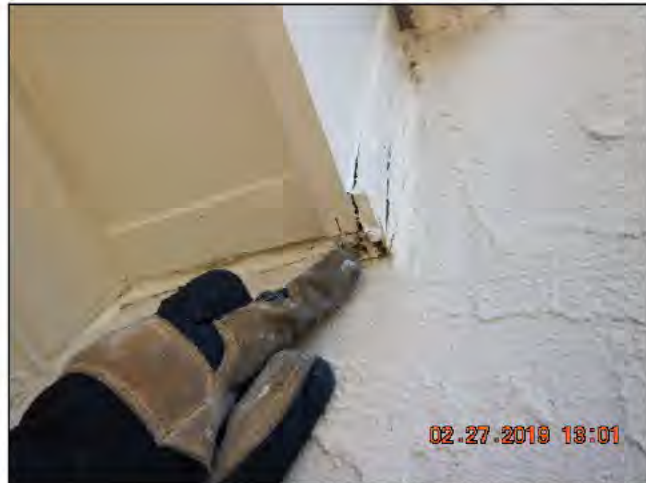
**6.1.A A7**

(1) Wood rot below kickout on left side of chimney.

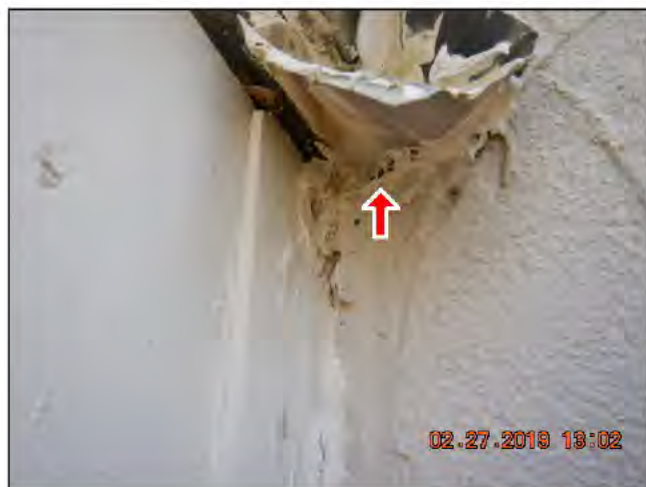
(2) Caulk missing / thin below kickout. Mesh visible. Repair needed.

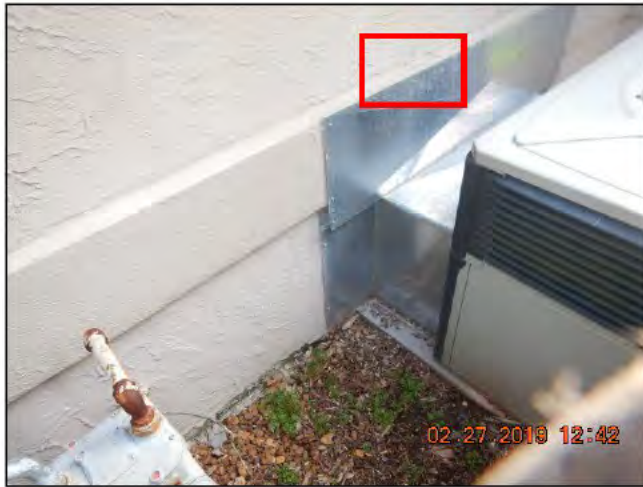
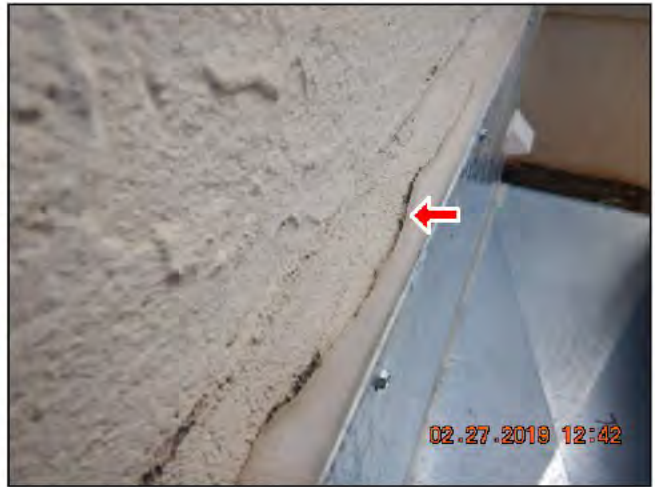
**6.2.A H6**

(1) Caulk failing at HVAC ductwork shroud. Recommend repair / caulk as needed.

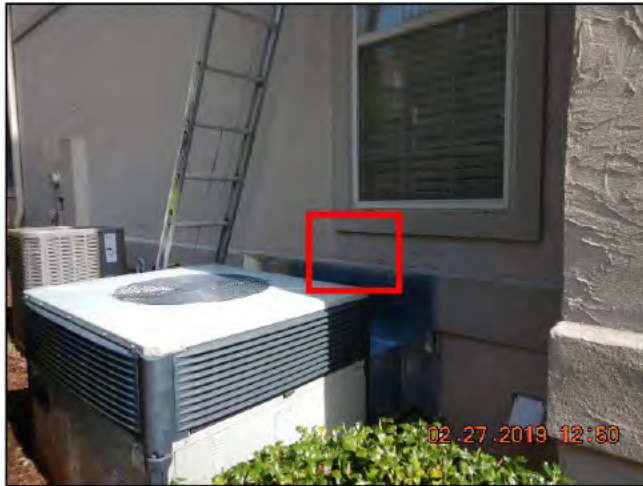
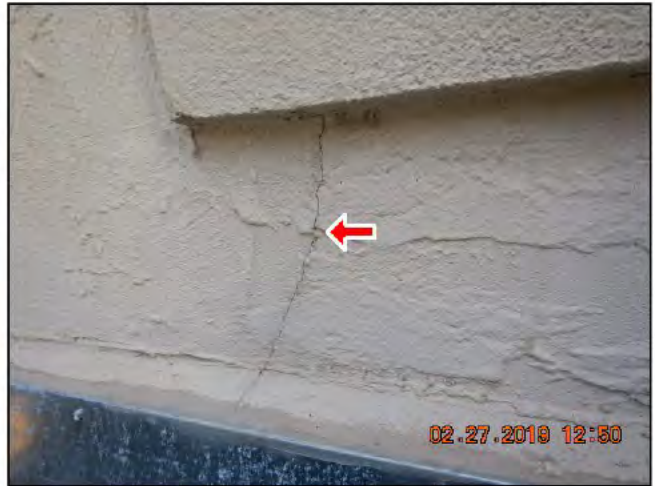
(2) Some cracking at various areas around home.

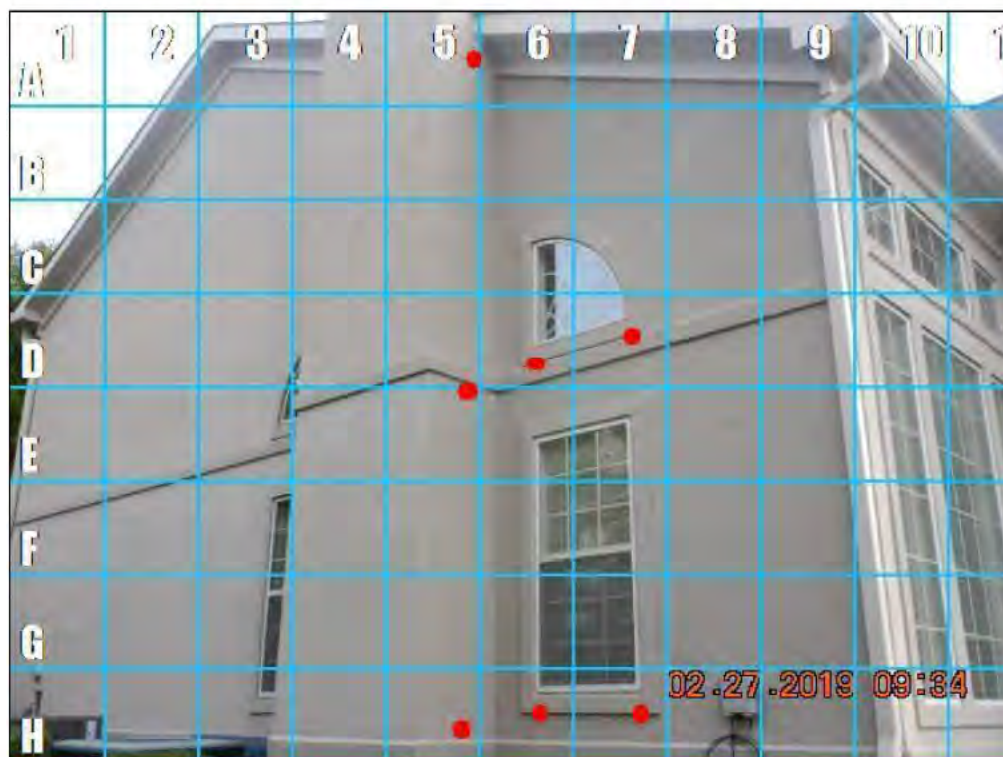
### 6.0.B GRID VIEW

Grid Location	Item Description	Moisture Readings	Substrate Condition	Observations
A5	Kickout	32.7	Firm	Elevated moisture below kickout.
D5	Kickout	46	Firm	Elevated moisture below kickout.
H5	Kickout	46	Soft	Elevated moisture below kickout.
H6	Window	9.7	Firm	Area where moisture reading was obtained.
H7	Window	9.0	Firm	Area where moisture reading was obtained.
D6	Window	46	Firm	Elevated moisture below window.
D7	Window	14.8	Firm	Area where moisture reading was obtained.

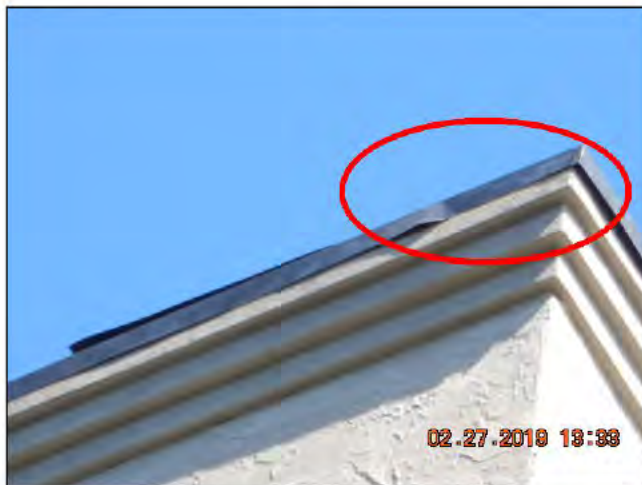
**6.1.B A4**

Chimney cap is bent and may have damaged stucco. A stucco repair contractor should evaluate and repair as needed.

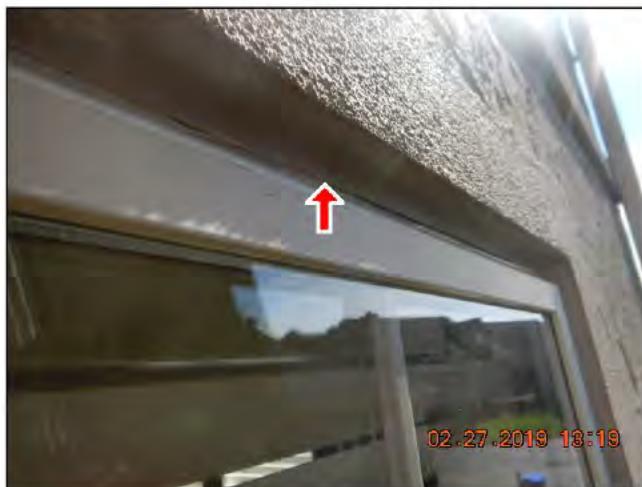
### 6.2.B E7

Window head flashing not installed on bottom window nearest corner on left side of home.

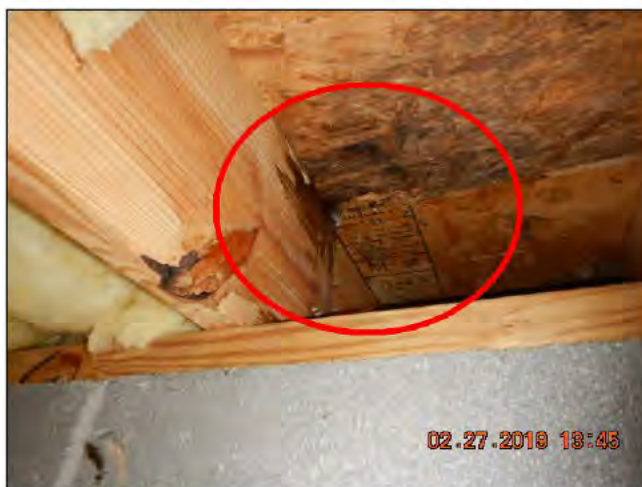
### 6.3.B H5

Moisture stains near chimney on rim joist, floor joists, and subfloor in crawlspace.
