**Inspection Report  
Sample Report**

**Best Choice  
Inspections**

Address: 100 Anywhere Lane, Knoxville, TN 37919

**Inspector: Jon Walz TN - 1126  
P.O. Box 14205  
Knoxville, TN 37914  
Tel: 865-804-2422  
3/9/2020**

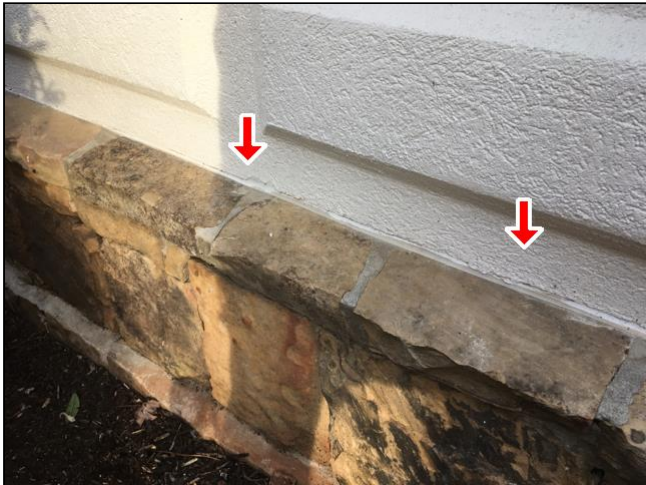
(3) Grid Coordinates: G9

No flashing visible at rock ledge.  
Caulk is present at stucco to rock joint.  
Typical at most areas around the home.

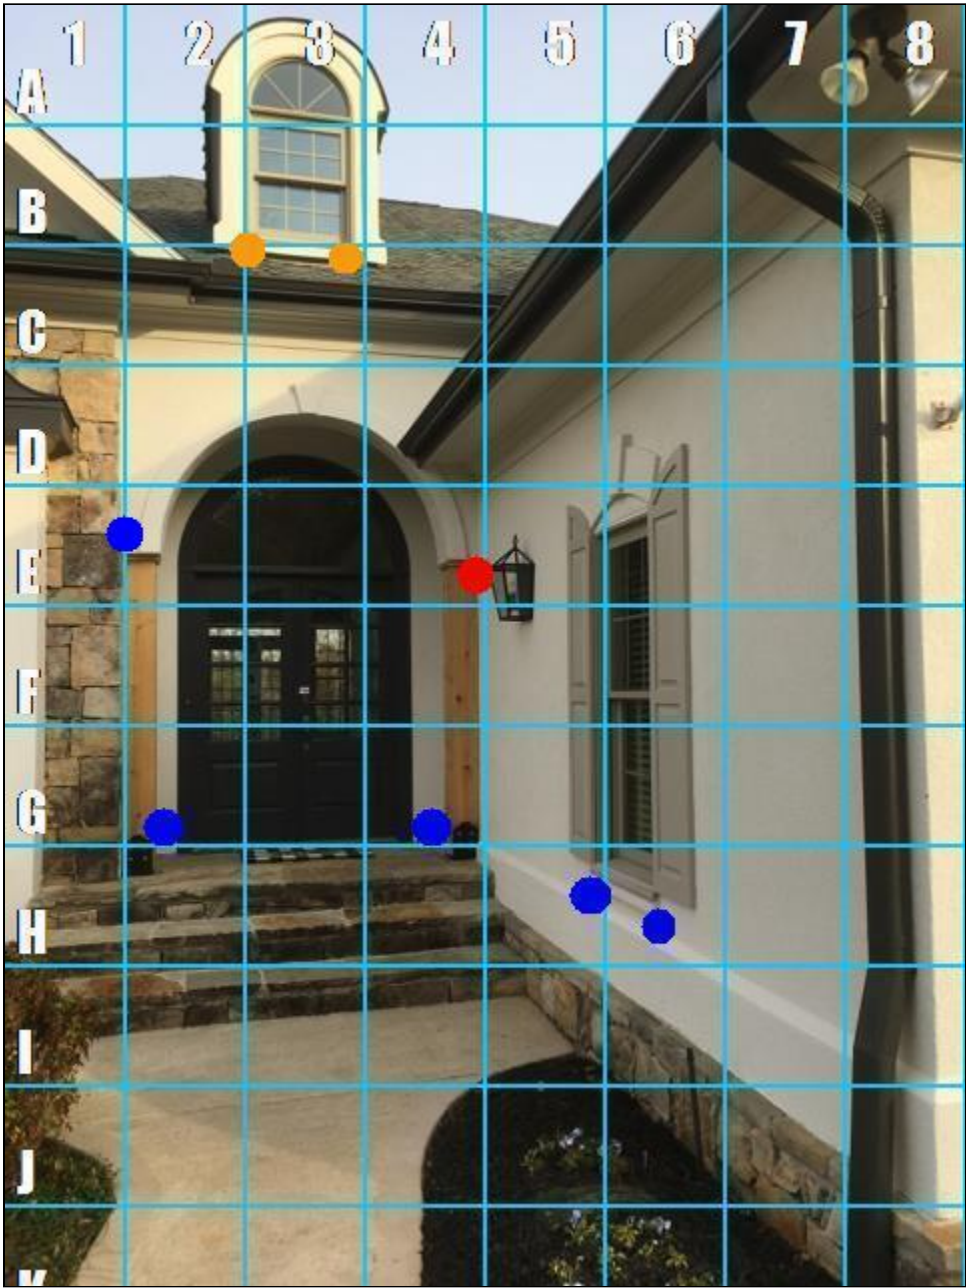
3.0.B Grid View

Grid Location	Item Description	Moisture Readings	Substrate Condition	Observations
E4	Kickout	51.1%	Firm	Elevated moisture level below kickout.

You have areas below windows and kickout flashing that are showing signs of elevated moisture. These areas should be evaluated by a qualified EIFS repair contractor.

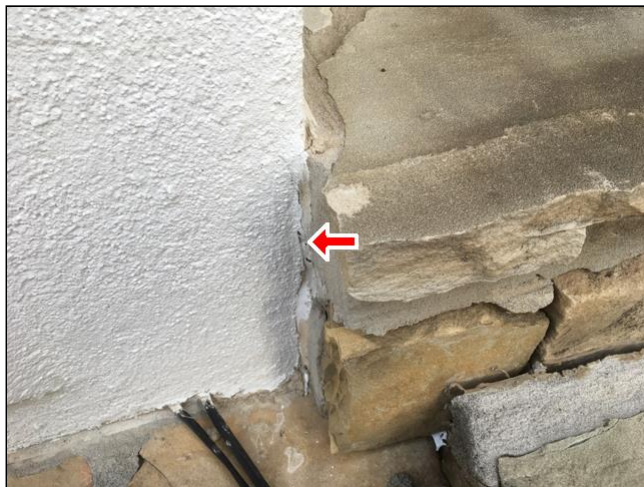
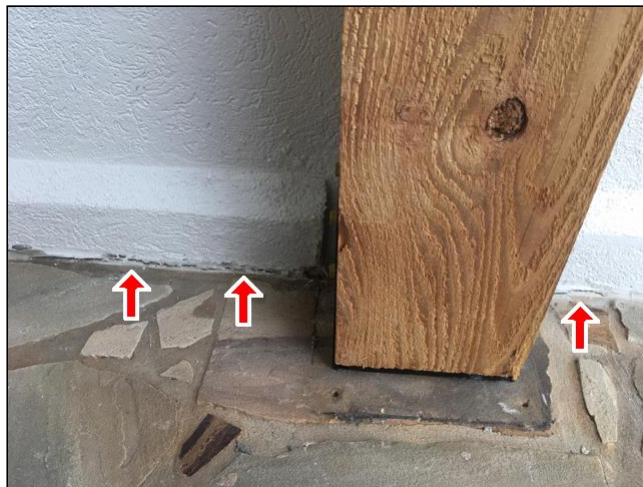
(1) Grid Coordinates: H1 & G4

Caulk failing and/or at stucco to rock joint at front porch. No flashing visible at this location.

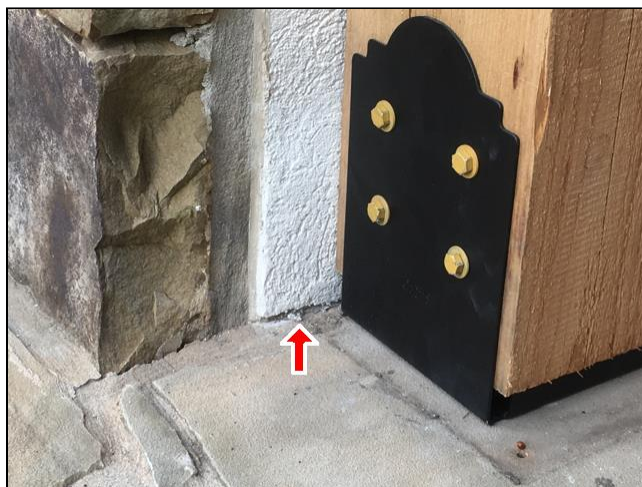
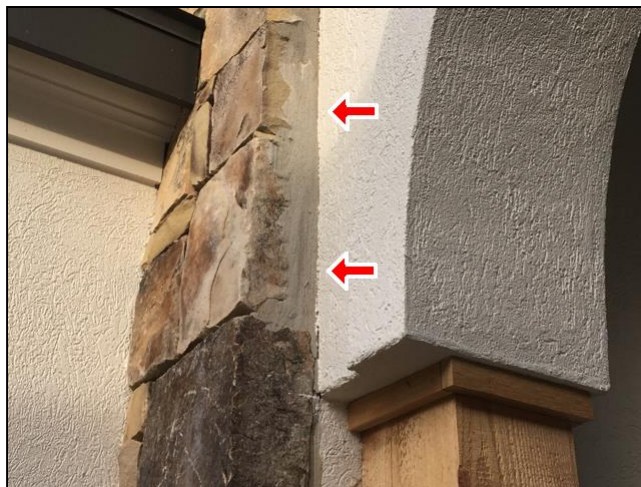
(2) Grid Coordinates: D1

Caulk missing at dissimilar material at stucco to rock joint. Typical at most stucco to rock joints around home.

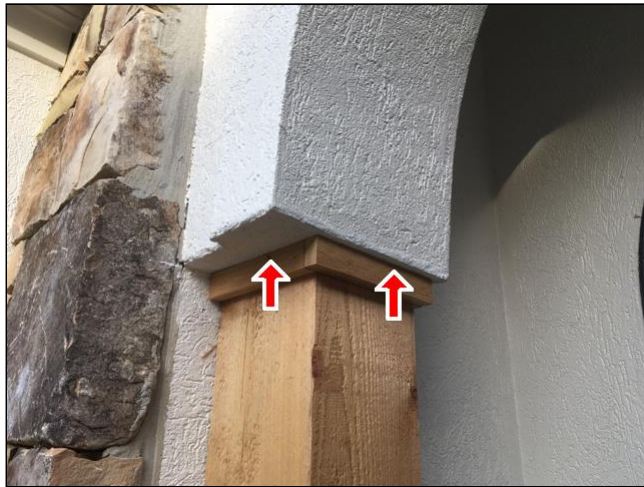
(3) Grid Coordinates: E2 & E4

No flashing and/or caulk visible at stucco to wood joint at front porch columns.

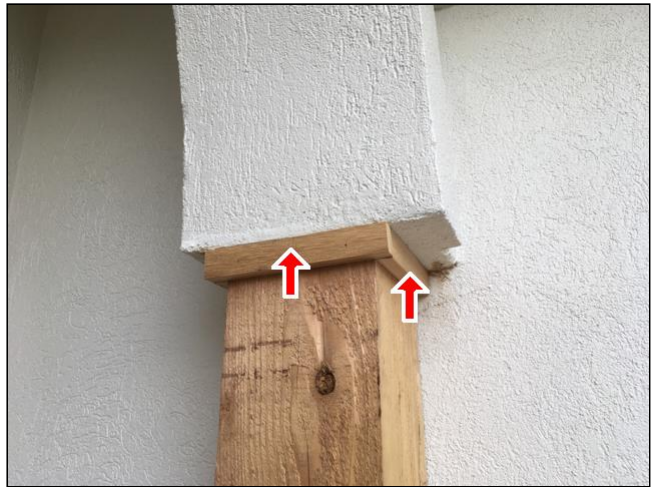
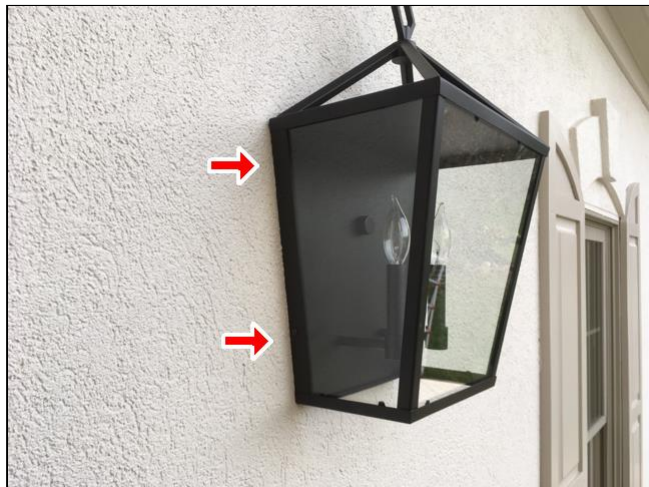
(4) Grid Coordinates: E5

Caulk missing at light fixture base.  
Typical at all light fixtures around home.

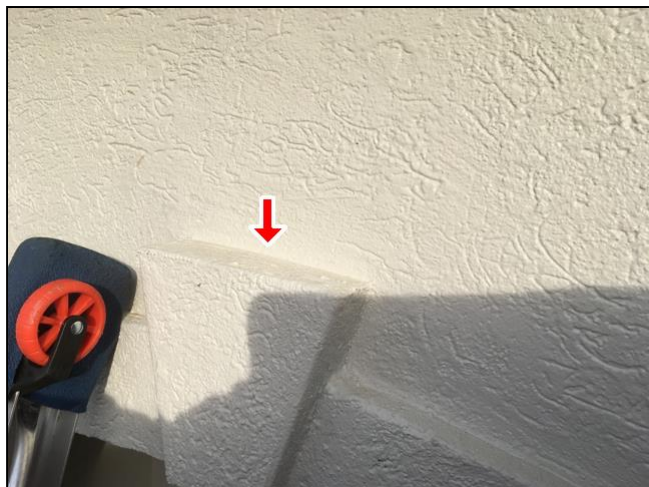
(5) Grid Coordinates: D3

Flat accent projecting more than 1 and 1/2 inch from wall is not caulked to wall line. Typical at all keystones.

All flat accents projecting 1 1/2" or more should be caulked at the wall line.

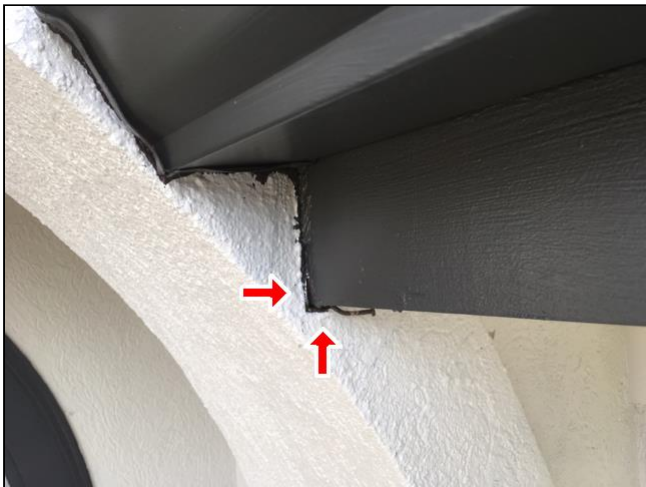
(6) Grid Coordinates: D4

Caulk failing at fascia board to stucco joint.

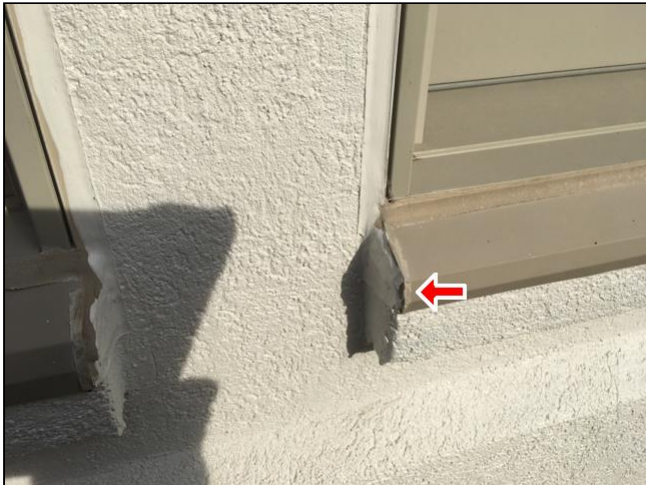
Grid Coordinates: G4

Caulk failing at window.

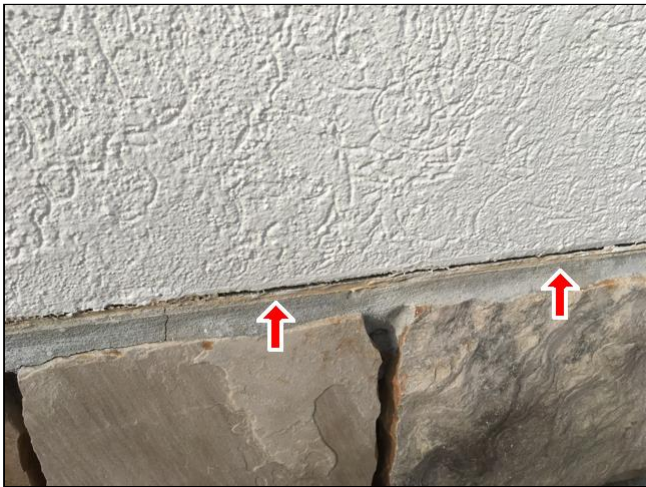
(1) Grid Coordinates: G2

Caulk failing at stucco to rock joint at this location.

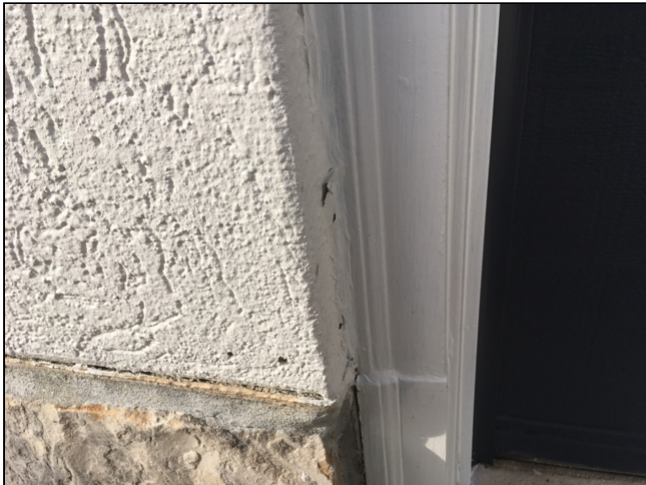
(2) Grid Coordinates: F3

Caulk failing at door.

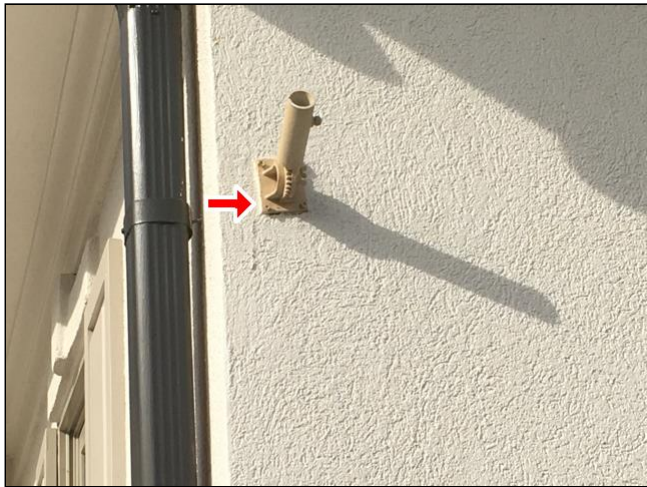
(1) Grid Coordinates: C1 & E6

Recommend verify fasteners at attachments where fasteners are not visible are properly sleeved and/or sealed.

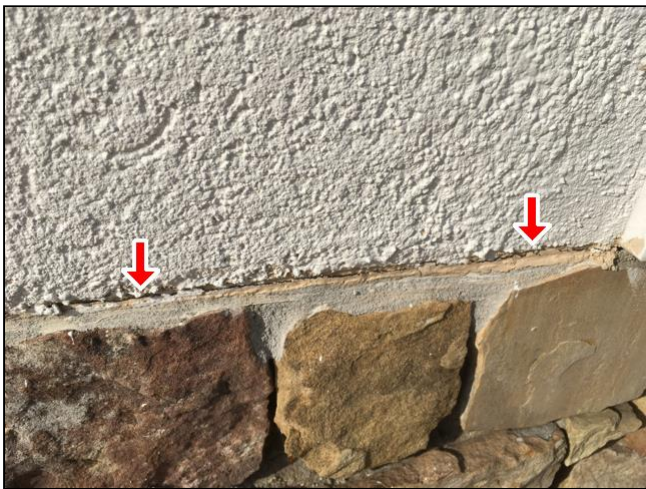
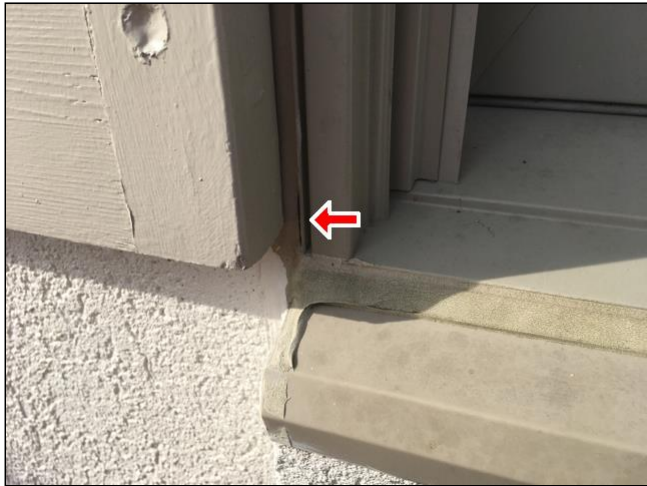
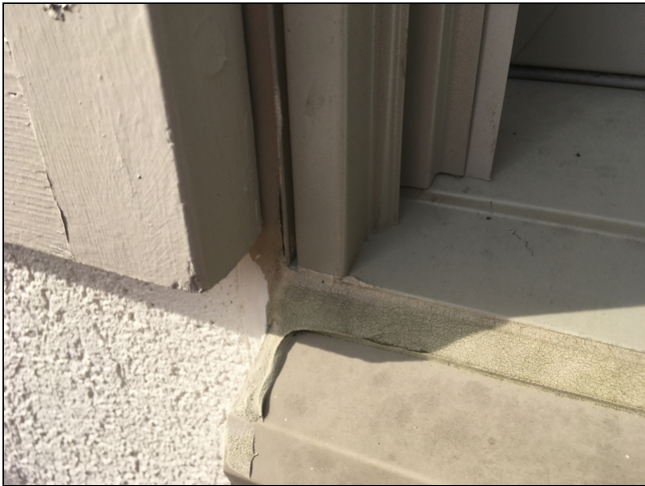
(3) Grid Coordinates: F6

Caulk failing at window.

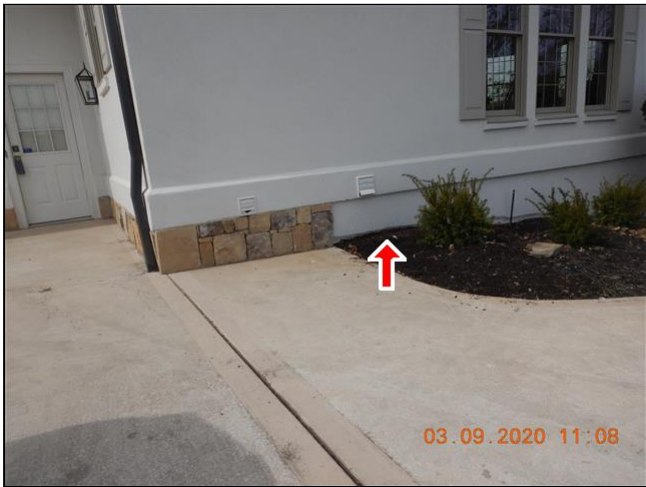
(4) Grid Coordinates: G4

Bottom of stucco to close to grade at this location.

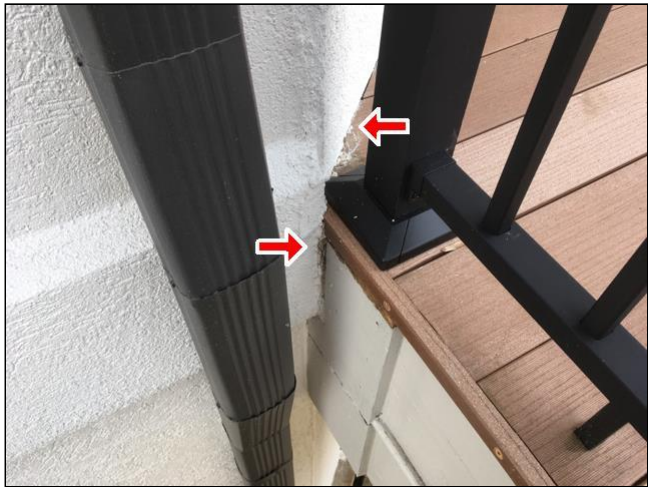
(1) Grid Coordinates: F7

No flashing visible above and/or below deck. No end dam flashing at deck ends.

Deck attachment flashing was not visible at all locations. End dams may need to be added at deck edges.

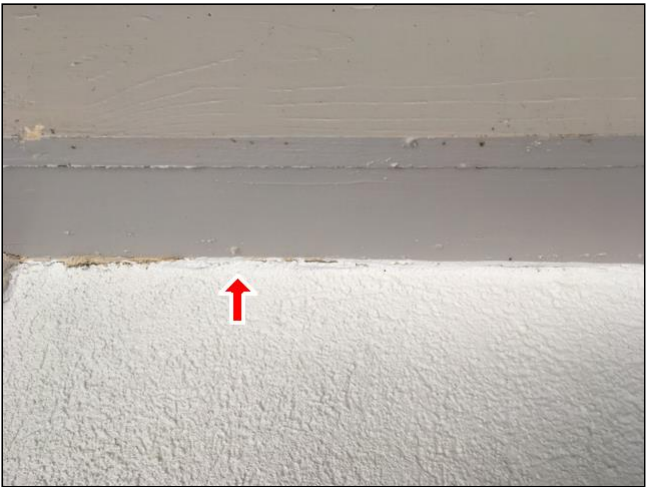
(2) Grid Coordinates: E6

Caulk failing at window.

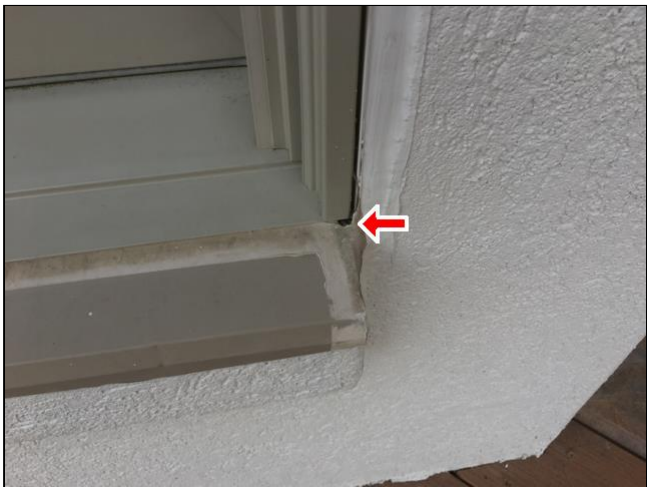
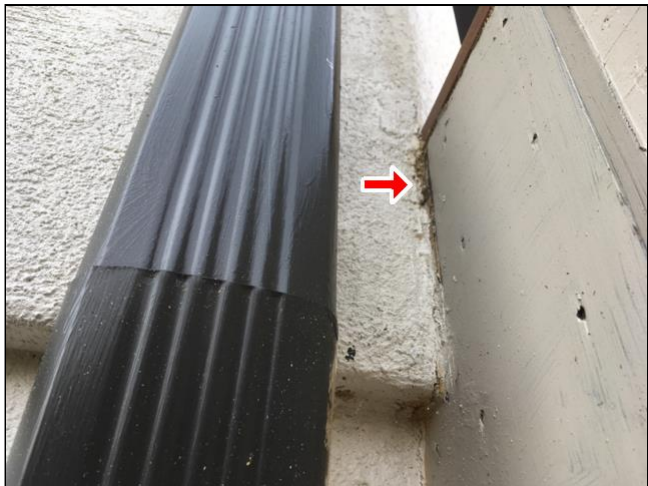
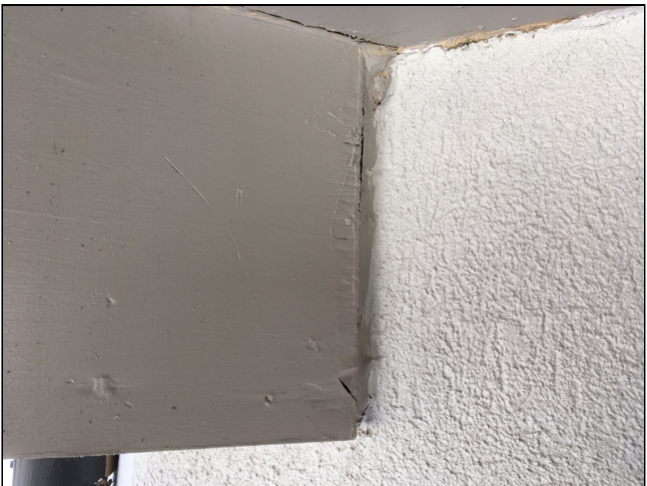
(3) Grid Coordinates: F7

Caulk failing at stucco to wood joint at side of the deck.

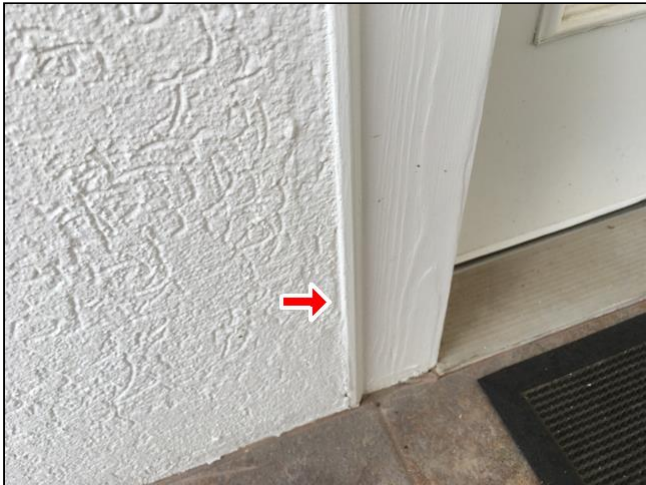
(1) Grid Coordinates: F1

Caulk missing at door. Typical at all doors at rear elevation.

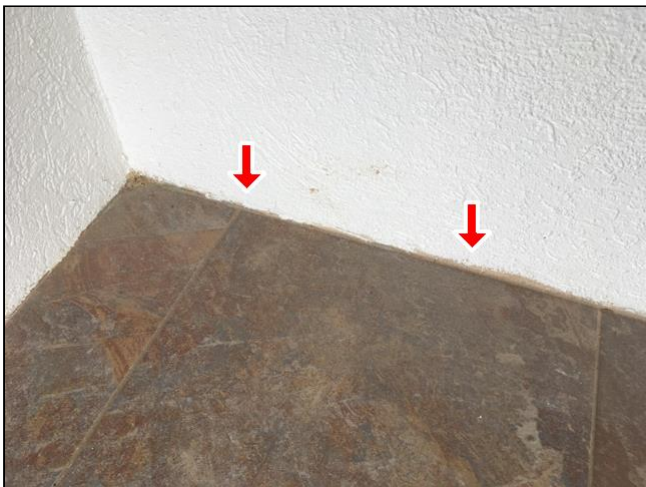
(2) Grid Coordinates: F3

No visible flashing or isolation joint at stucco to tile joint at rear porch.

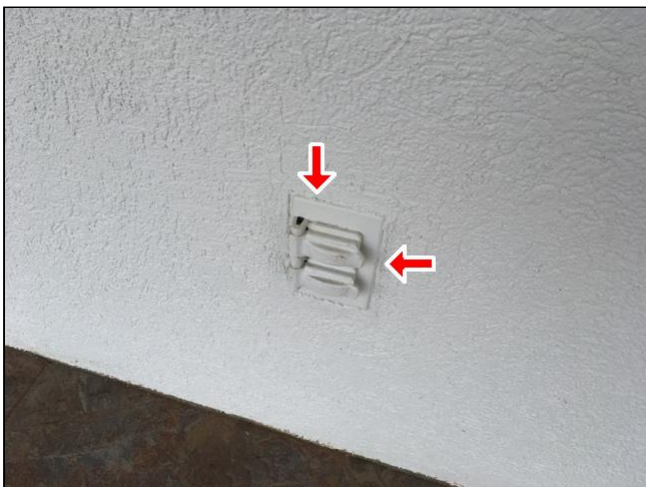
(3) Grid Coordinates: F5

Caulk missing at outlet. Typical at all outlets at rear elevation.

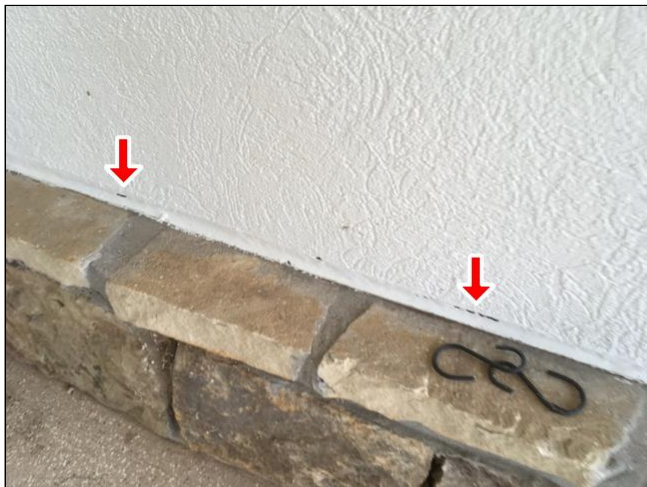
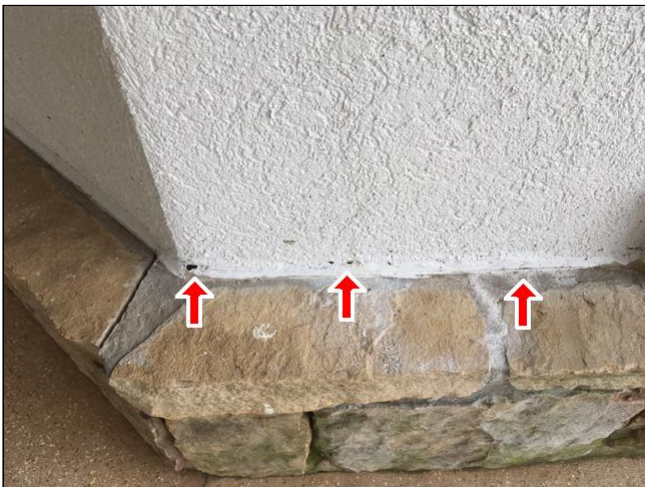
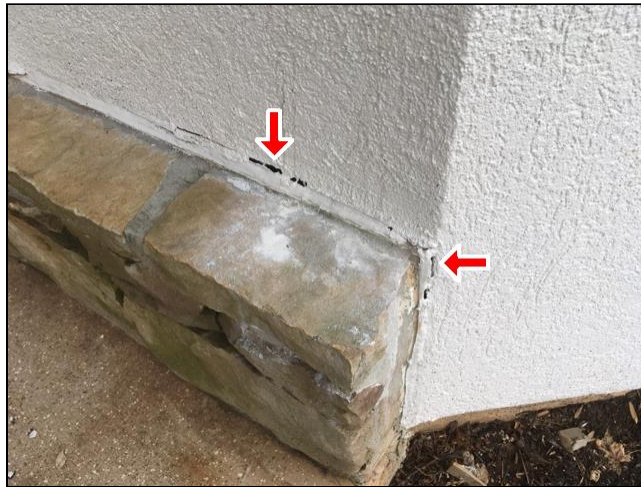
(1) Grid Coordinates: H2

Caulk failing at stucco to rock ledge joint at this location.

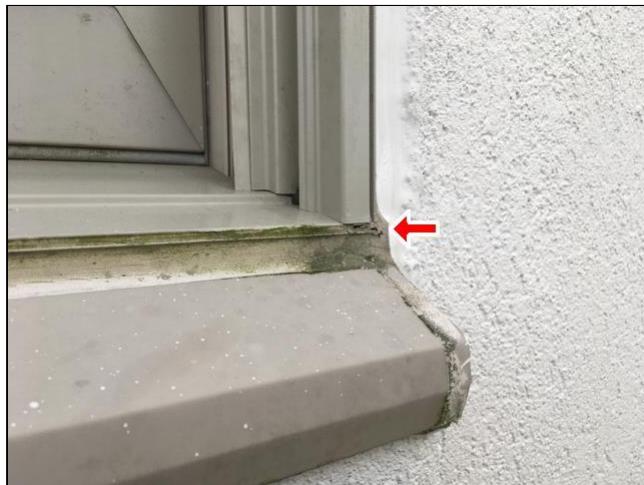
(2) Grid Coordinates: C7

Caulk failing your window.

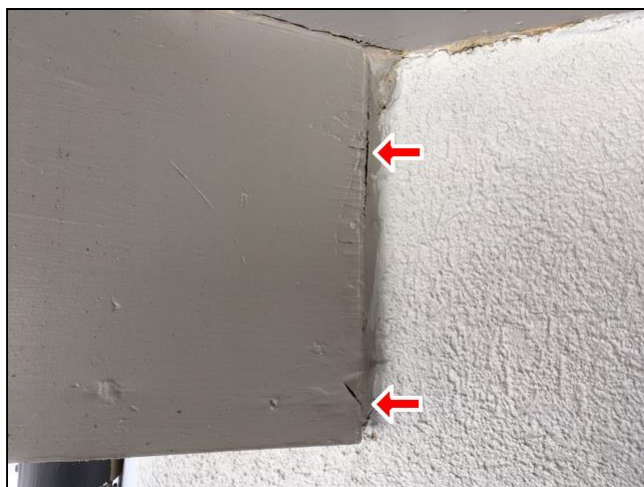
(3) Grid Coordinates: D3

Caulk failing at stucco to wood joint at side of the deck.

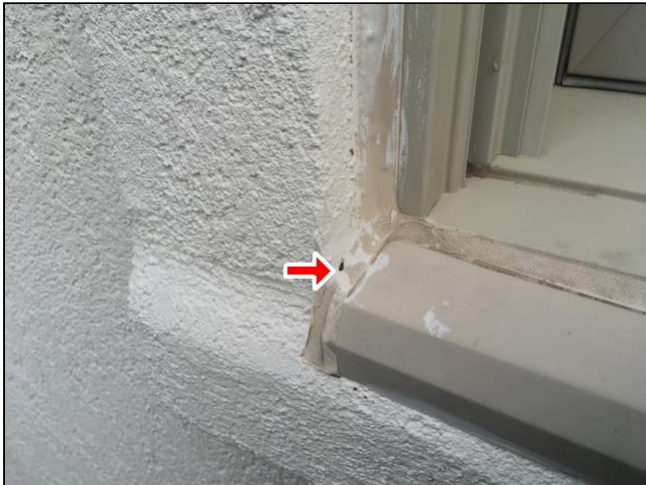
Grid Coordinates: H2

Caulk failing at window. Typical at all windows on left elevation.

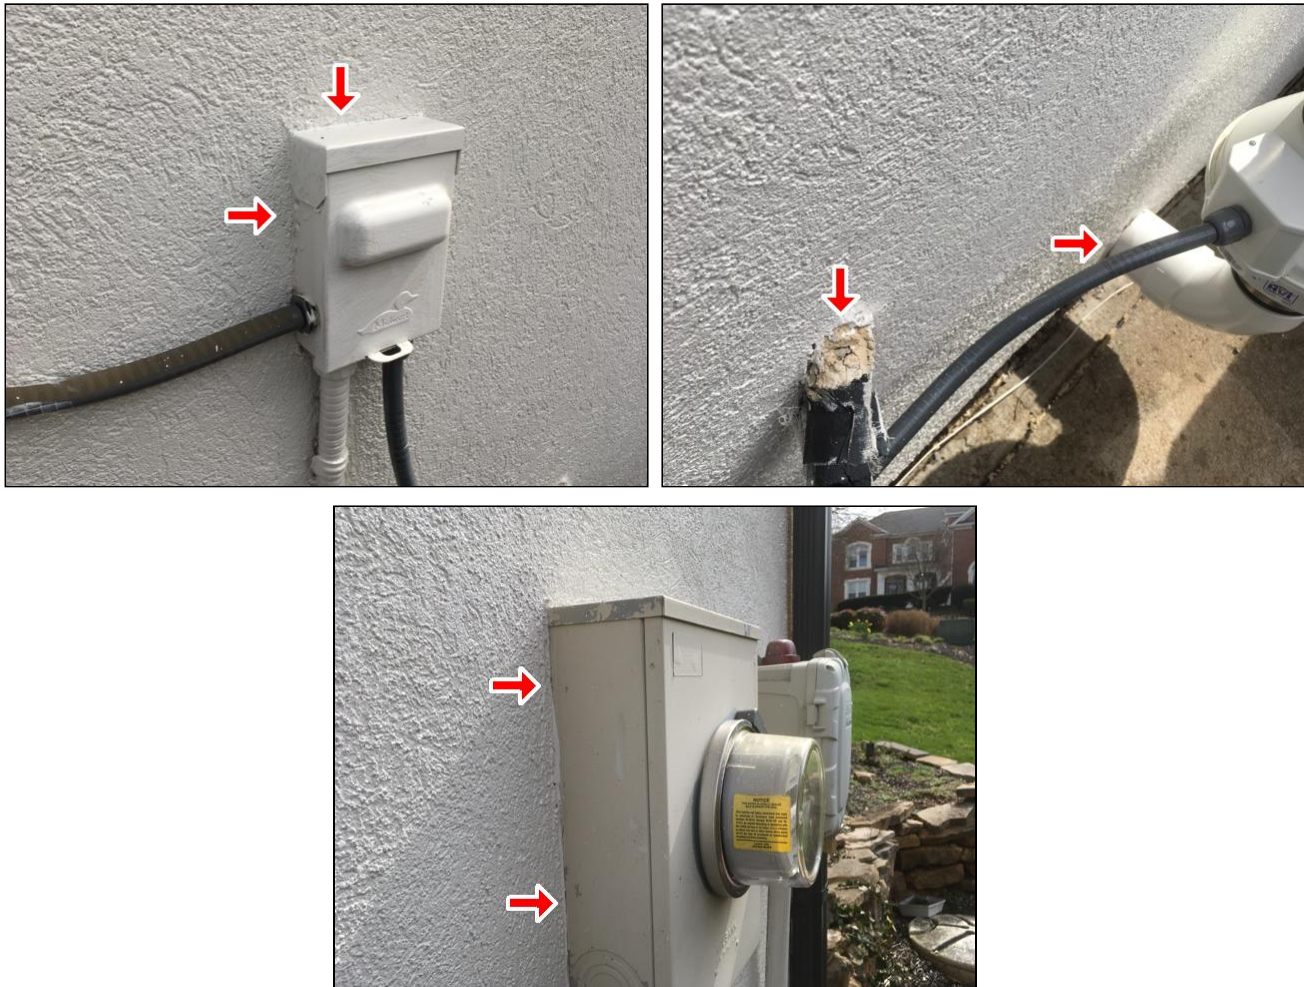
(1) Grid Coordinates: G2, H3, F10

Caulk missing at utility attachments/penetrations at this location. Typical for all utility attachments/penetrations on left elevation.

Caulk or re-caulk any place below the soffit line where stucco meets another material. This may include utility penetrations, light fixtures, vents, dissimilar materials, downspout fasteners or other types of breaches to the stucco system.

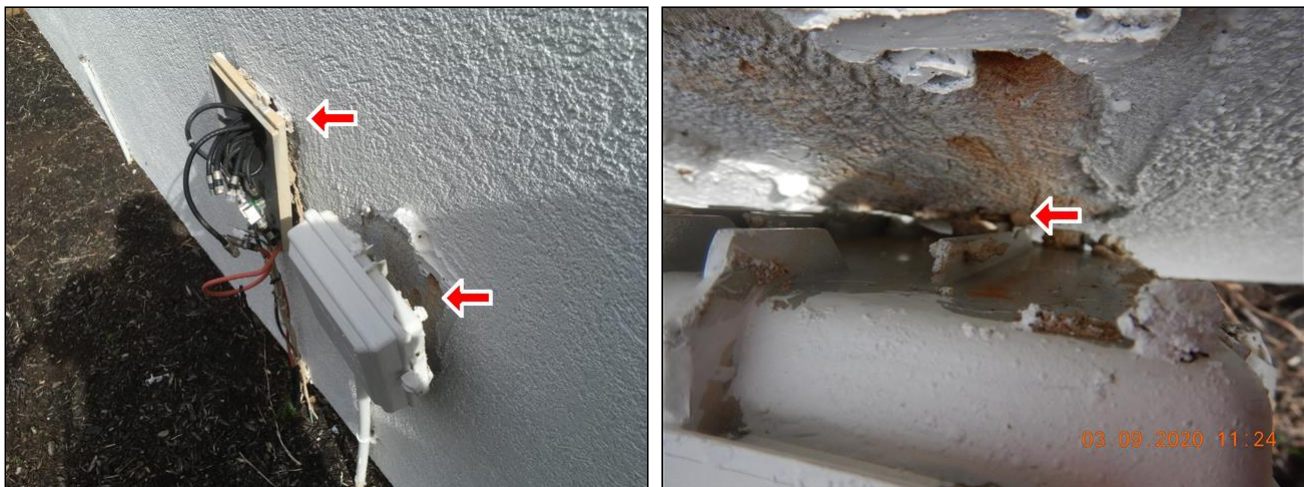
(2) Grid Coordinates: G9

Utility attachments are loose on wall at this location and fasteners do not appear properly sleeved/sealed.

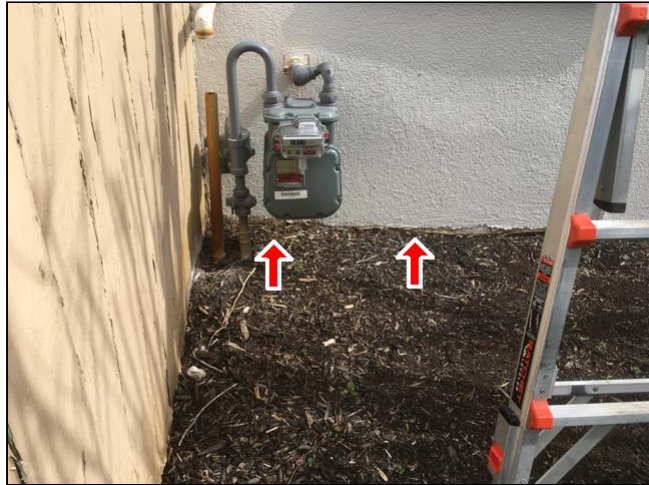
(3) Grid Coordinates: H5 - H6

Stucco extends to and/or below grade at this location.

Foam insulation is in direct contact with the ground. This area should be modified to prevent insect infestations.

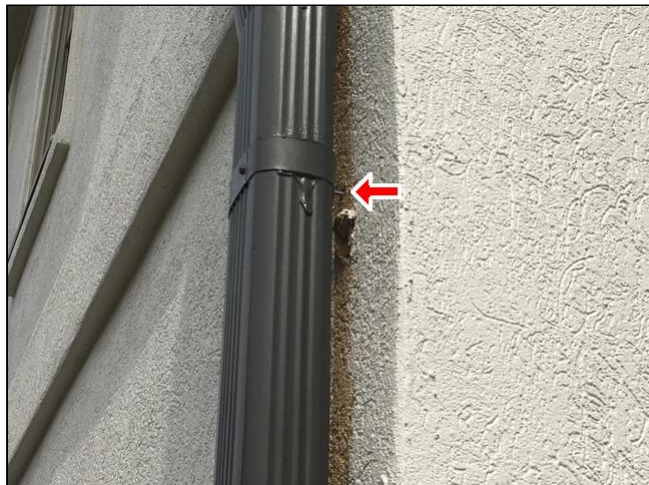
(4) Grid Coordinates: F11

Downspout fastener at this location does not appear properly sleeved/sealed.
