**Inspection Report
Sample Report**

**Best Choice
Inspections**

Address: 100 Anywhere Lane, Knoxville, TN 37919

EIFS Inspection Summary

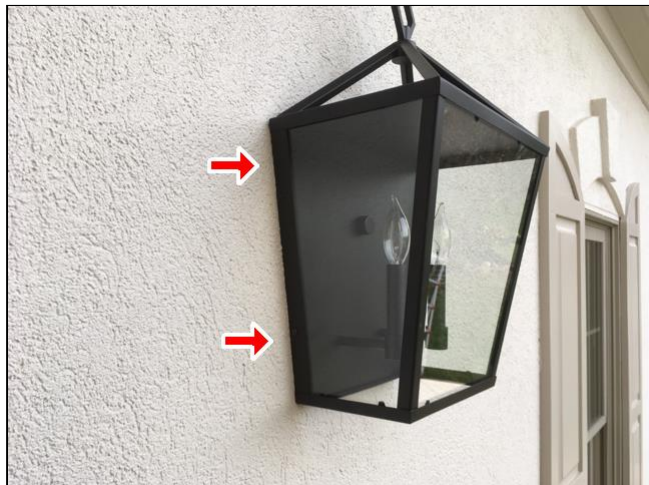
(4) Grid Coordinates: E5

Caulk missing at light fixture base.
Typical at all light fixtures around home.

Caulk or re-caulk any place below the soffit line where stucco meets another material. This may include utility penetrations, light fixtures, vents, dissimilar materials, downspout fasteners or other types of breaches to the stucco system.

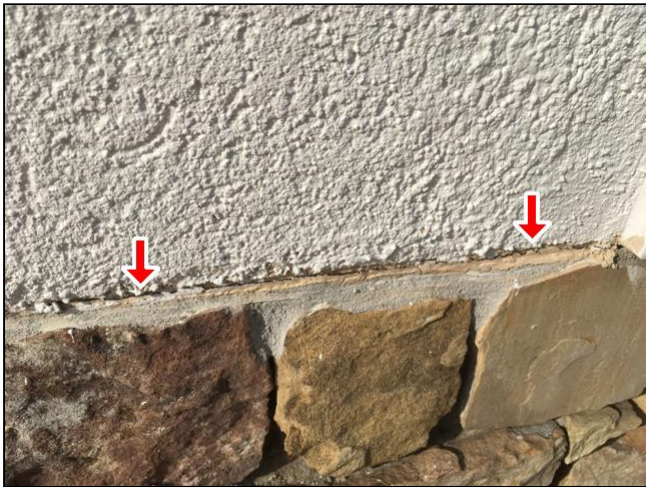
(3) Grid Coordinates: F6

Caulk failing at window.

Re-caulk doors and windows as indicated in the report. For single or double hung windows, seal the tracks on all vertical joints from the head of the window to the sill and along the bottom joint of the track to the sill and at least 6" up the vertical joints behind the track. For casement windows, caulk or re-caulk all exposed joints, including the miter joints of the window.

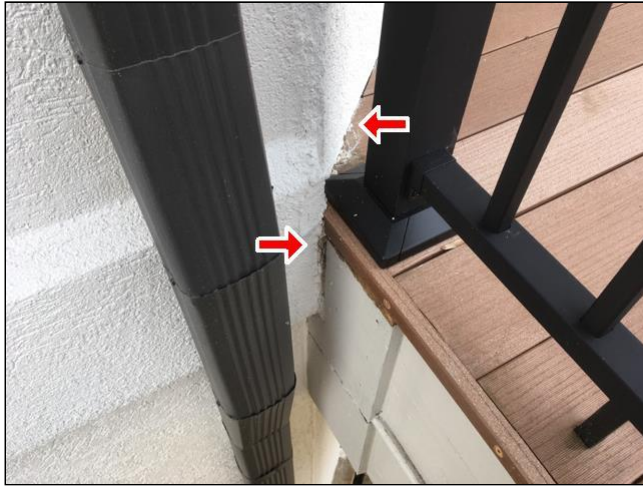
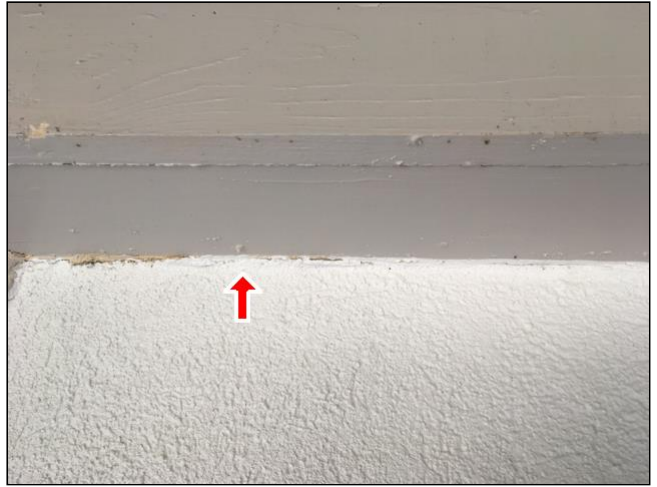
(1) Grid Coordinates: F7

No flashing visible above and/or below deck. No end dam flashing at deck ends.

Deck attachment flashing was not visible at all locations. End dams may need to be added at deck edges.

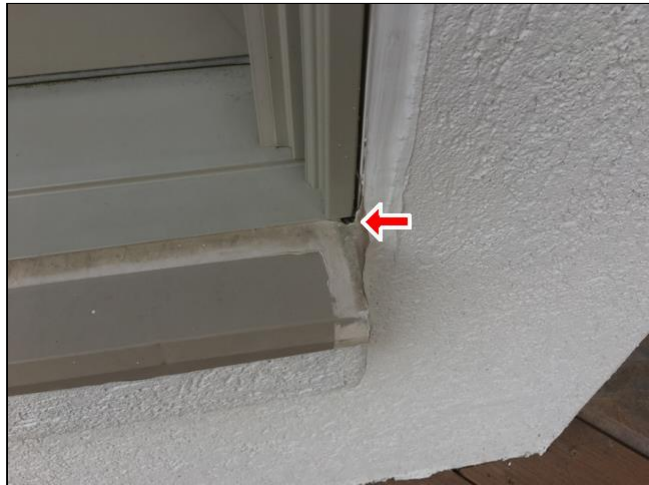
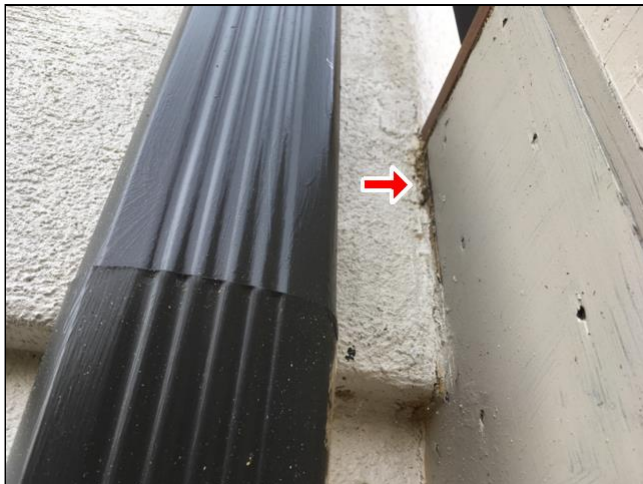
(2) Grid Coordinates: E6

Caulk failing at window.

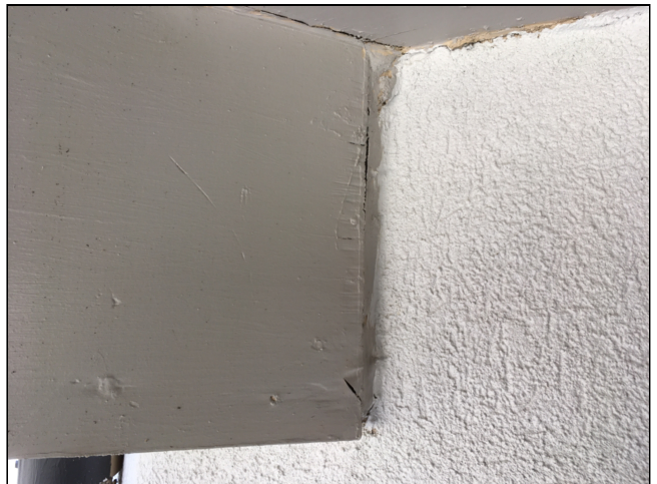
(3) Grid Coordinates: F7

Caulk failing at stucco to wood joint at side of the deck.

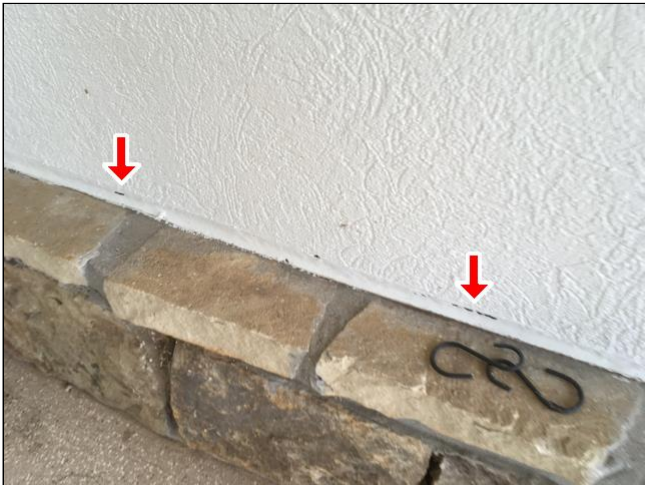
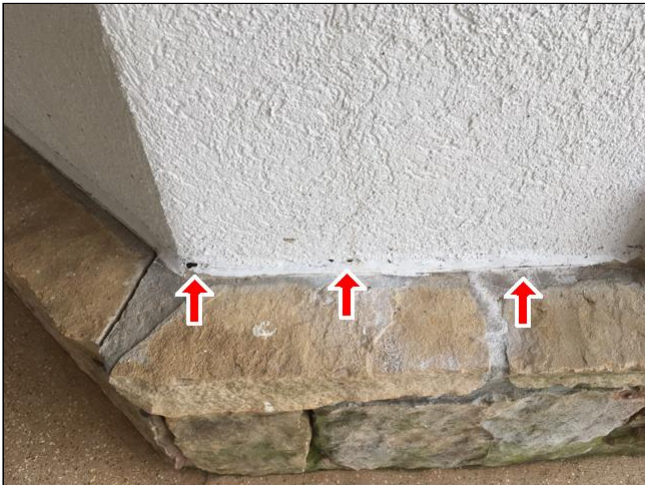
(1) Grid Coordinates: H2

Caulk failing at stucco to rock ledge joint at this location.
