**Inspection Report  
Sample Report**

**Best Choice  
Inspections**

Address: 100 Anywhere Lane, Knoxville, TN 37919

**Inspector: Jon Walz TN - 1126  
P.O. Box 14205  
Knoxville, TN 37914  
Tel: 865-804-2422  
3/9/2020**

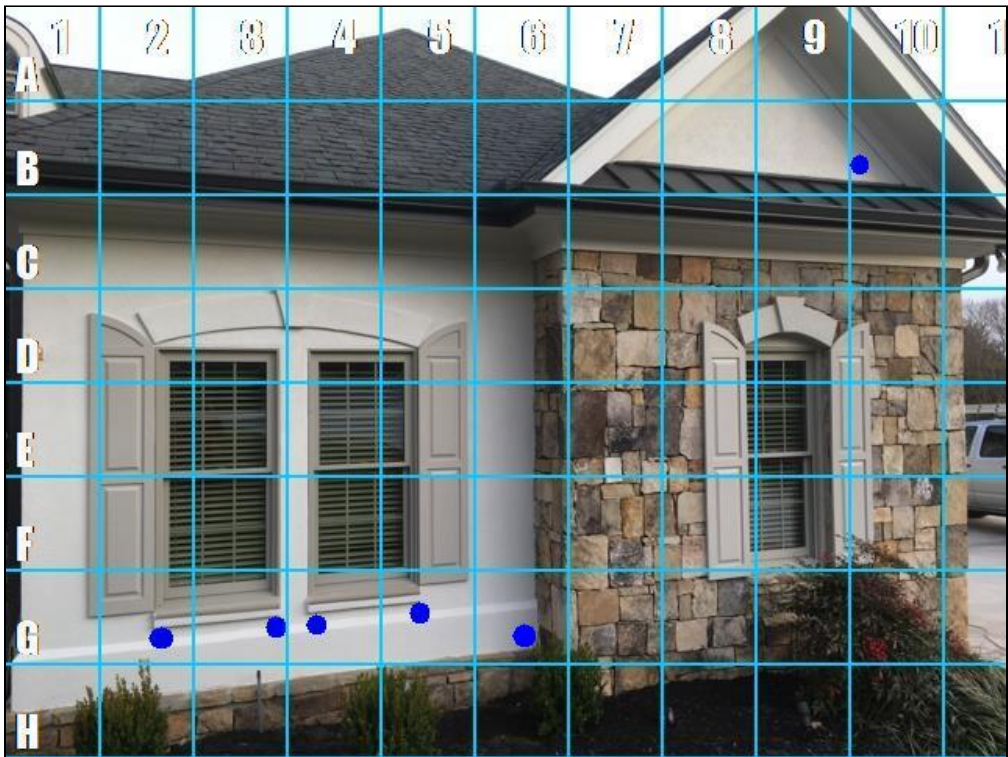
3.0.C Grid View

Grid Location	Item Description	Moisture Readings	Substrate Condition	Observations
None				No elevated readings obtained in this area.

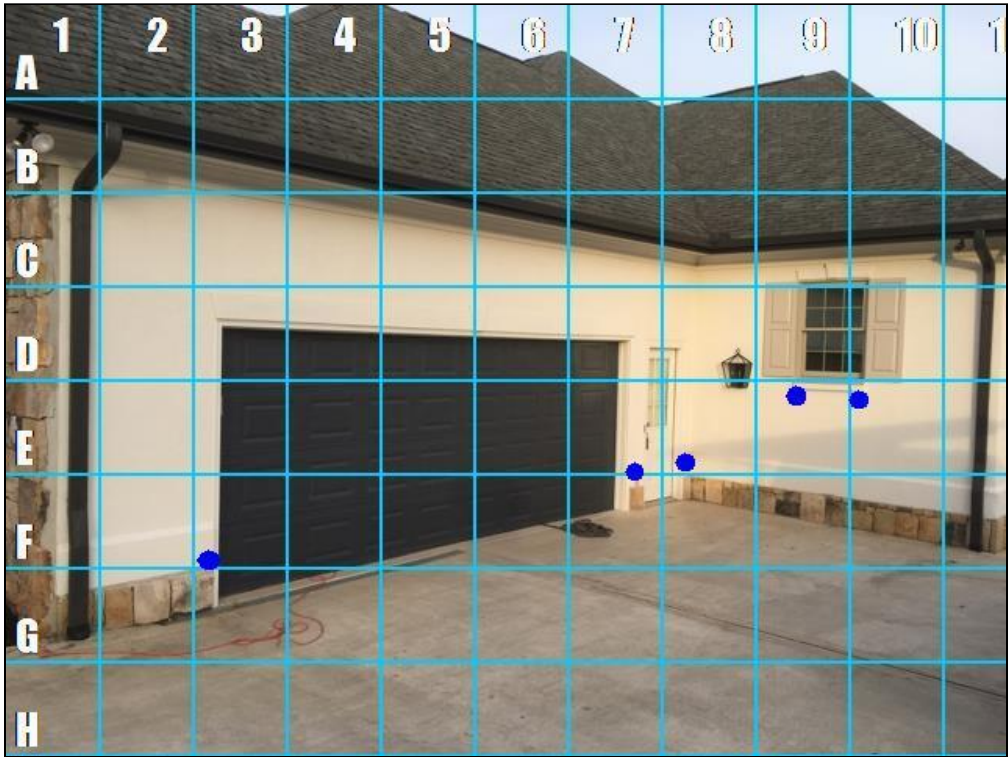
4.0.A GRID VIEW

Grid Location	Item Description	Moisture Readings	Substrate Condition	Observations
None				No elevated readings obtained in this area.

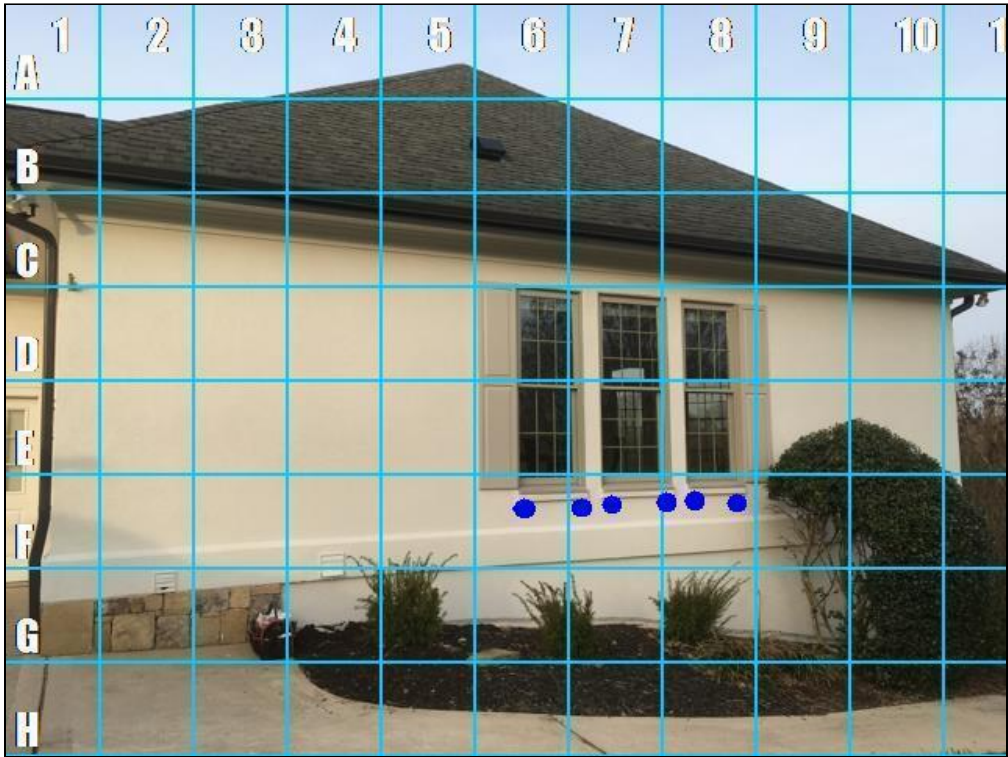
4.0.B GRID VIEW

Grid Location	Item Description	Moisture Readings	Substrate Condition	Observations
None				No elevated readings obtained in this area.

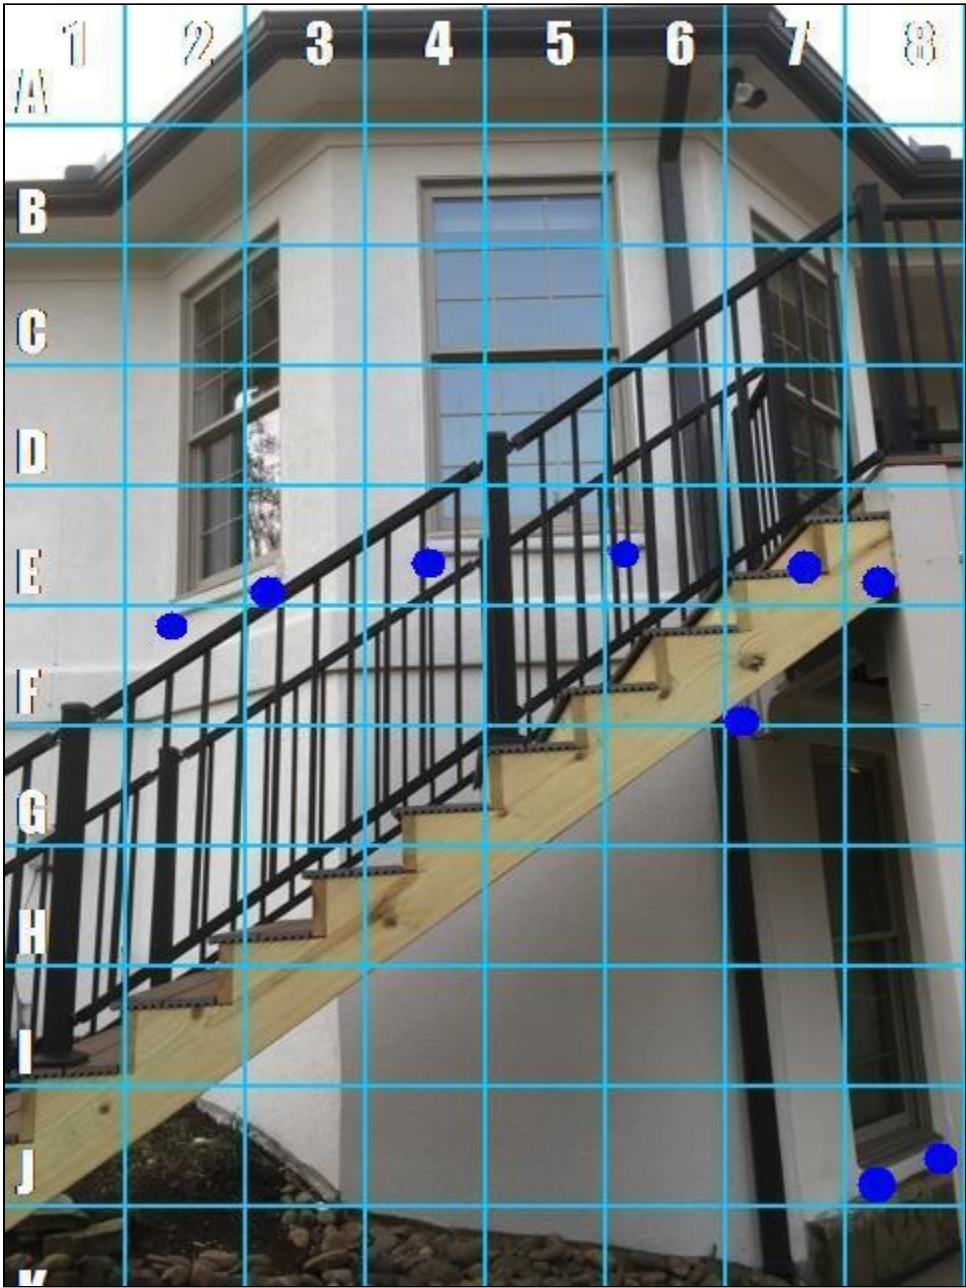
**5.0.A GRID VIEW**

Grid Location	Item Description	Moisture Readings	Substrate Condition	Observations
None				No elevated readings obtained in this area.

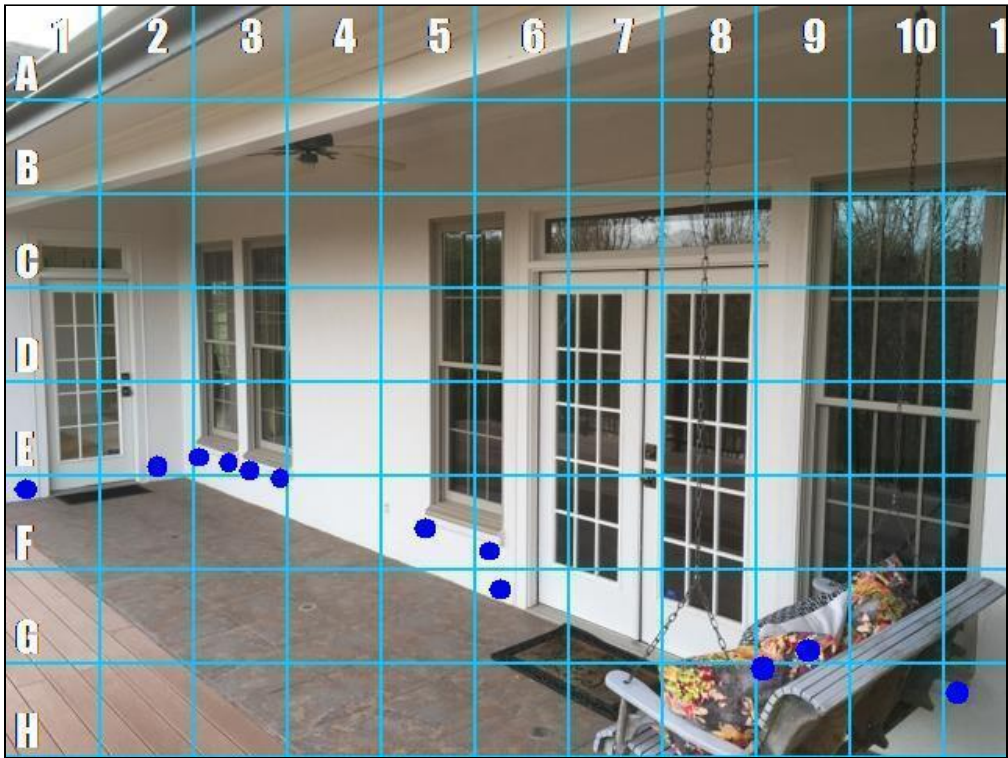
5.0.B GRID VIEW

Grid Location	Item Description	Moisture Readings	Substrate Condition	Observations
None				No elevated readings obtained in this area.

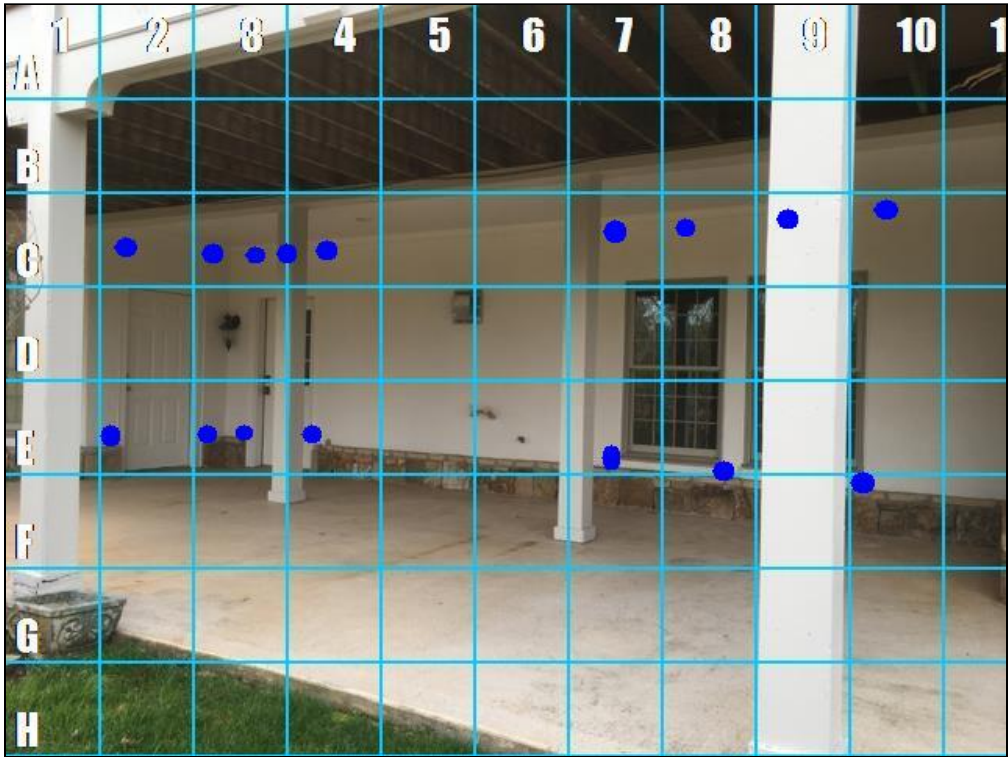
### 5.0.C GRID VIEW

Grid Location	Item Description	Moisture Readings	Substrate Condition	Observations
None				No elevated readings obtained in this area.

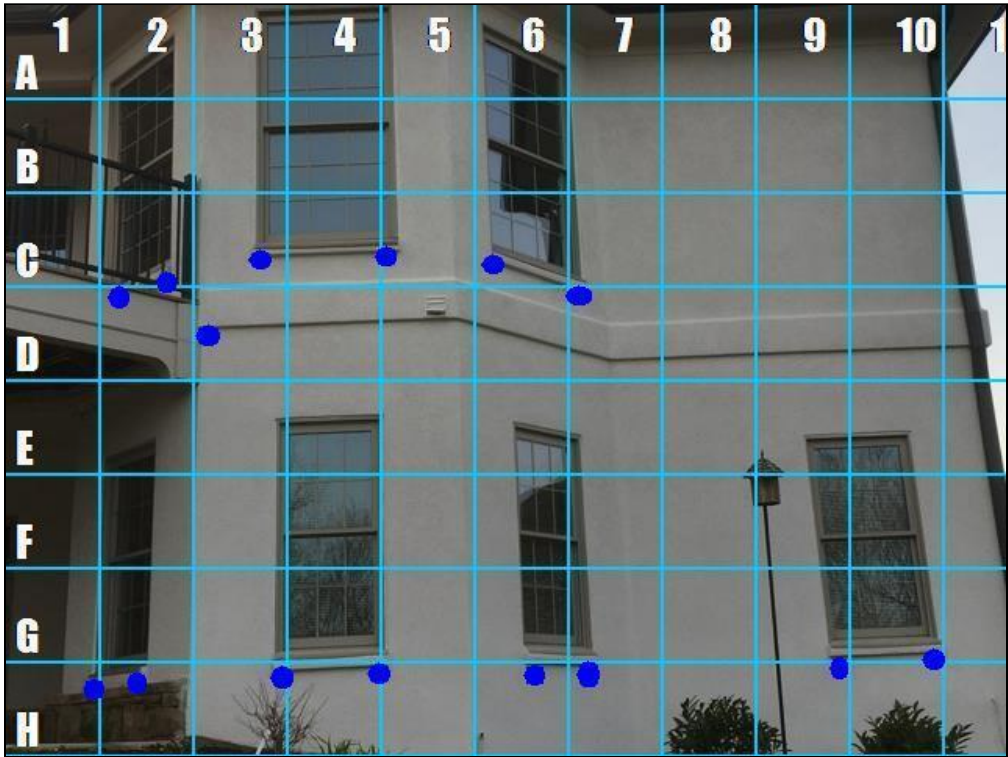
5.0.D GRID VIEW

Grid Location	Item Description	Moisture Readings	Substrate Condition	Observations
None				No elevated readings obtained in this area.

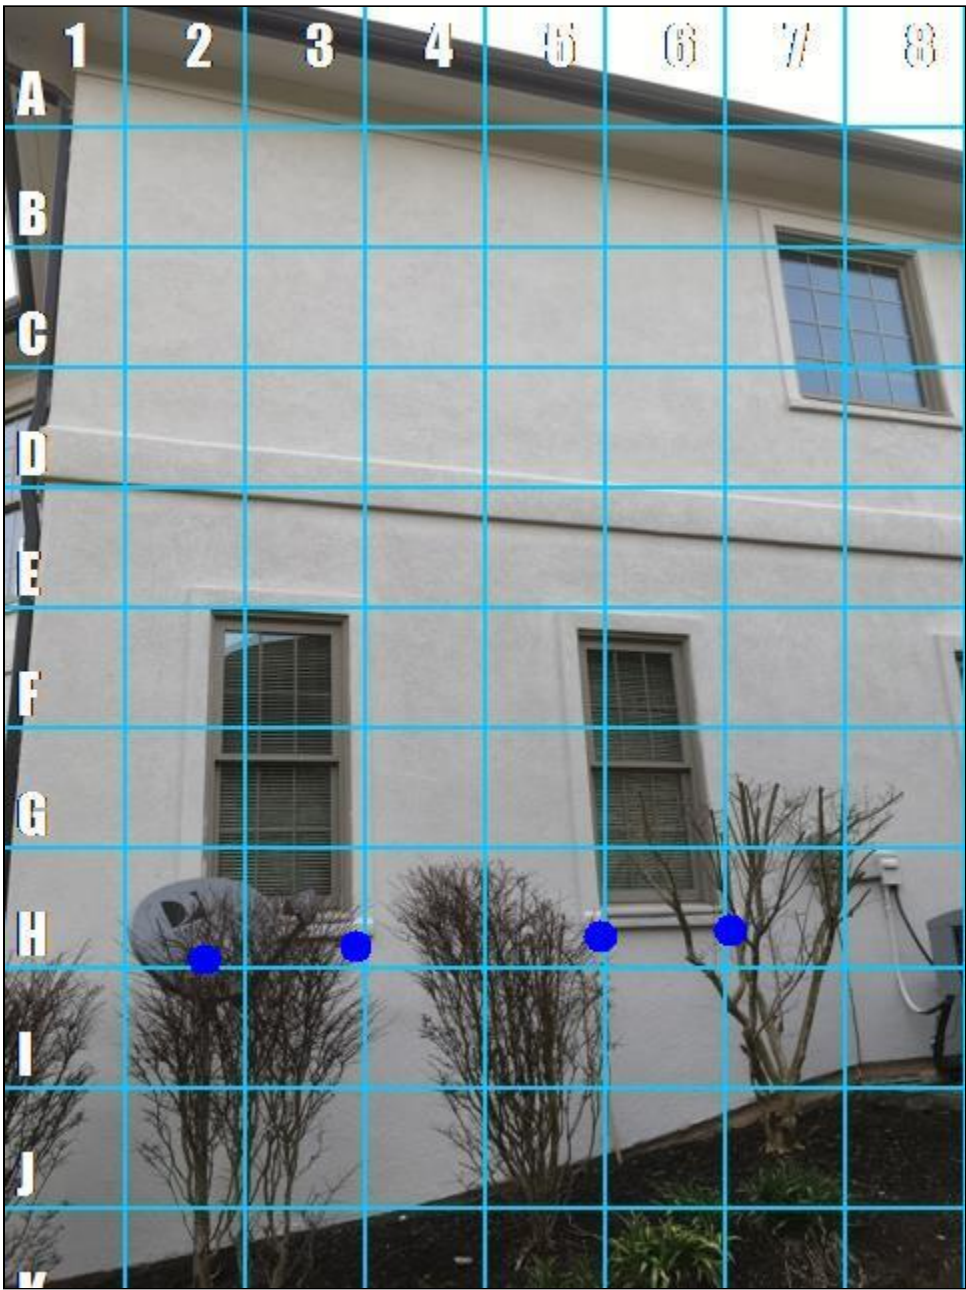
6.0.A GRID VIEW

Grid Location	Item Description	Moisture Readings	Substrate Condition	Observations
None				No elevated readings obtained in this area.

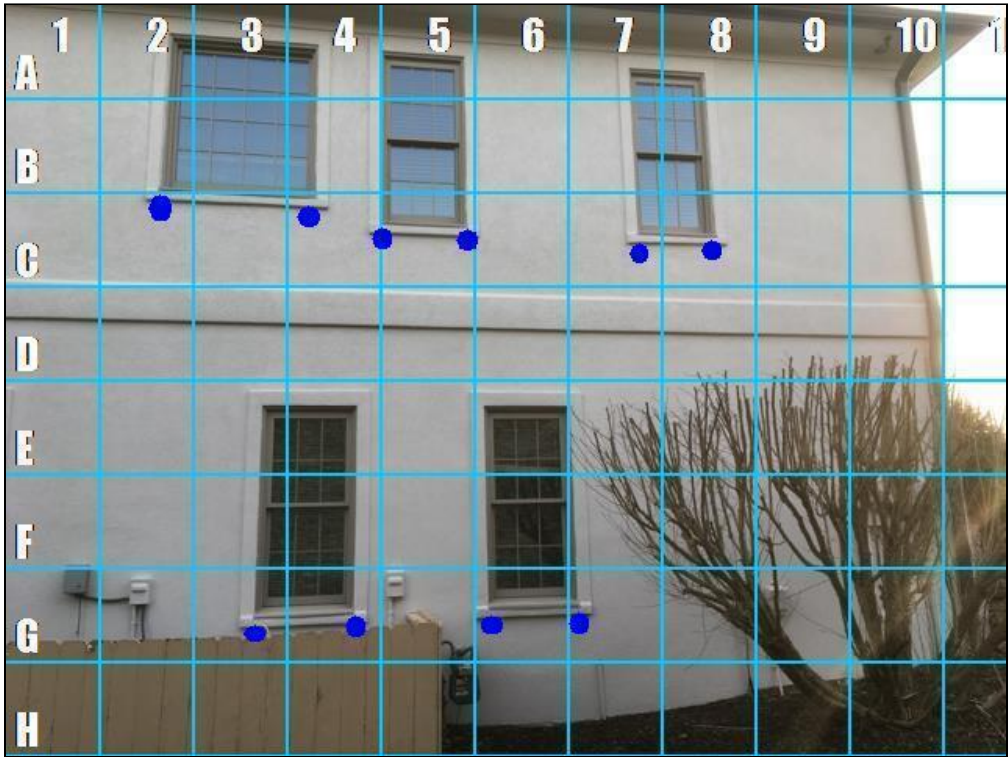
6.0.B GRID VIEW

Grid Location	Item Description	Moisture Readings	Substrate Condition	Observations
None				No elevated readings obtained in this area.
